Warrah Ridge: Waterways Constraints Assessment

Prepared for PSA Consulting Pty Ltd

Project Name	Warrah Ridge: Waterways Constraints Assessment
Project Number	20SYD-16318
Project Manager	Alex Gorey
Prepared by	Emily Messer
Reviewed by	Claire Wheeler and Miles Yeates
Approved by	Peter Hancock
Status	Final
Version Number	v4
Last saved on	13 October 2022

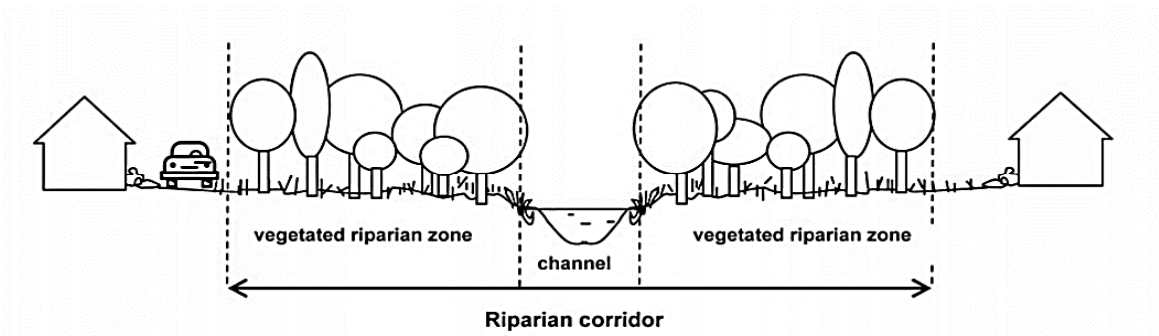
Figure 2: Vegetated Riparian Zone and watercourse channel comprising the riparian corridor (NRAR, 2018)

adjacent to the channel to provide a transition zone between the terrestrial environment and watercourse. This vegetated zone helps maintain and improve the ecological functions of a watercourse whilst providing habitat for terrestrial flora and fauna. The VRZ plus the channel (bed and banks of the watercourse to the highest bank) constitute the 'riparian corridor' (Figure 2). To be consistent with the guidelines, VRZ widths should be based on watercourse order as classified under the Strahler System of ordering watercourses applied to the Hydroline Spatial Data published on the department's website (Table 1).

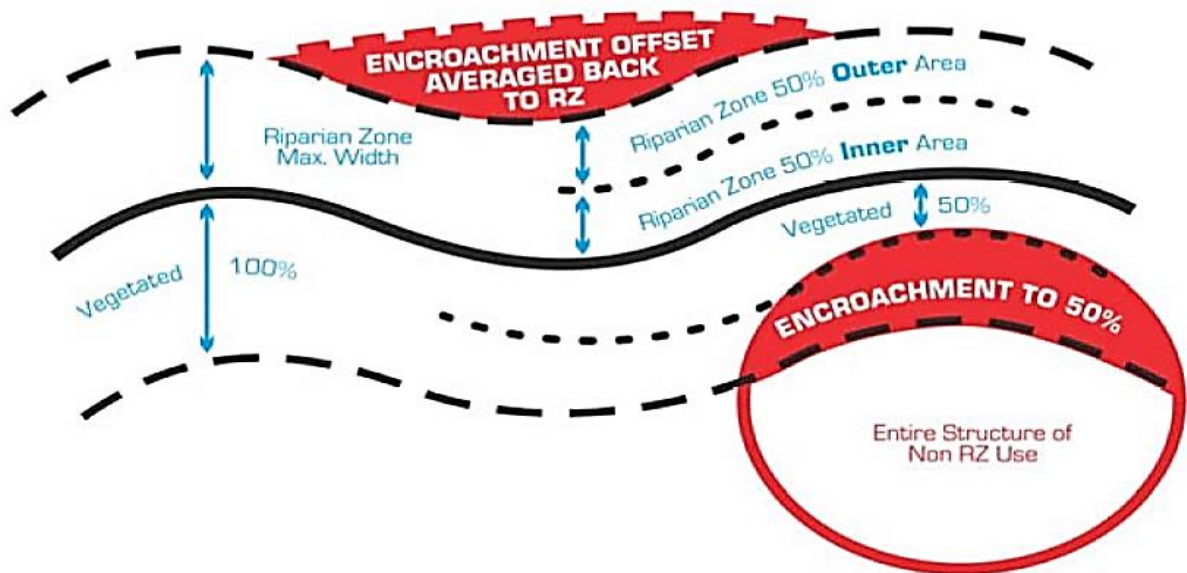
Figure 3: Riparian 'averaging rule' for offsetting encroachment into the outer 50% of the VRZ (NRAR 2018)

Certain works are permissible within the riparian zone (Table 2). Non-riparian uses are consistent with NRAR’s guidelines in the outer 50% of the VRZ as long as compensation (1:1 offset) is achieved within the site. The outer VRZ that is impacted must be offset elsewhere on site using the ‘averaging rule’ (Figure 3).

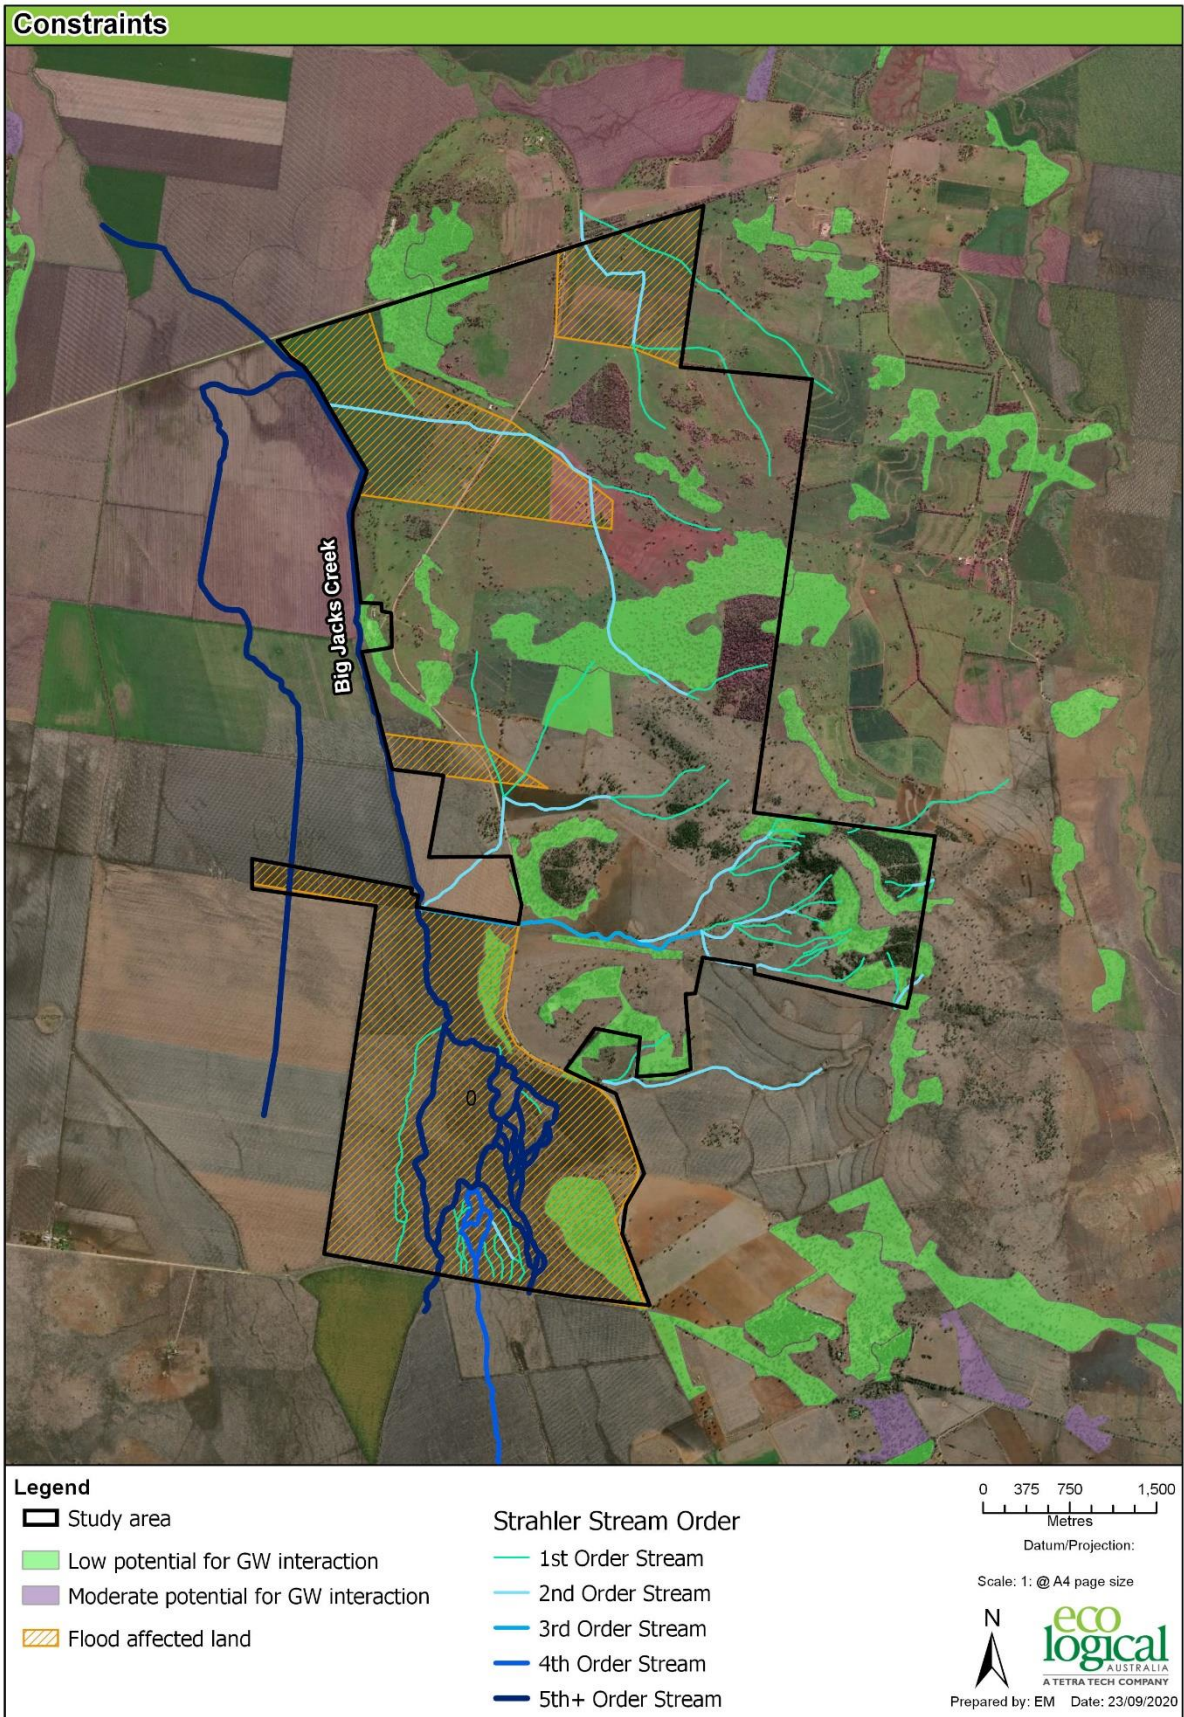
Figure 4: Desktop constraints

The areas deemed most highly constrained for development were those in the flood-prone areas, and the floodplain area to the south of the site with a network of streams surrounding Big Jacks Creek, a sixth-order creek that flows north along the site boundary.

After desktop examination, the first and second-order creeks mapped in Figure 5 were assessed as may not having a bed, bank or geomorphic process as they appeared from aerial imagery and contours to be low points in the landscape only, showing no differentiation between the creek and the adjacent landscape. These areas were highlighted and targeted in the field-validation (Section 5.2).

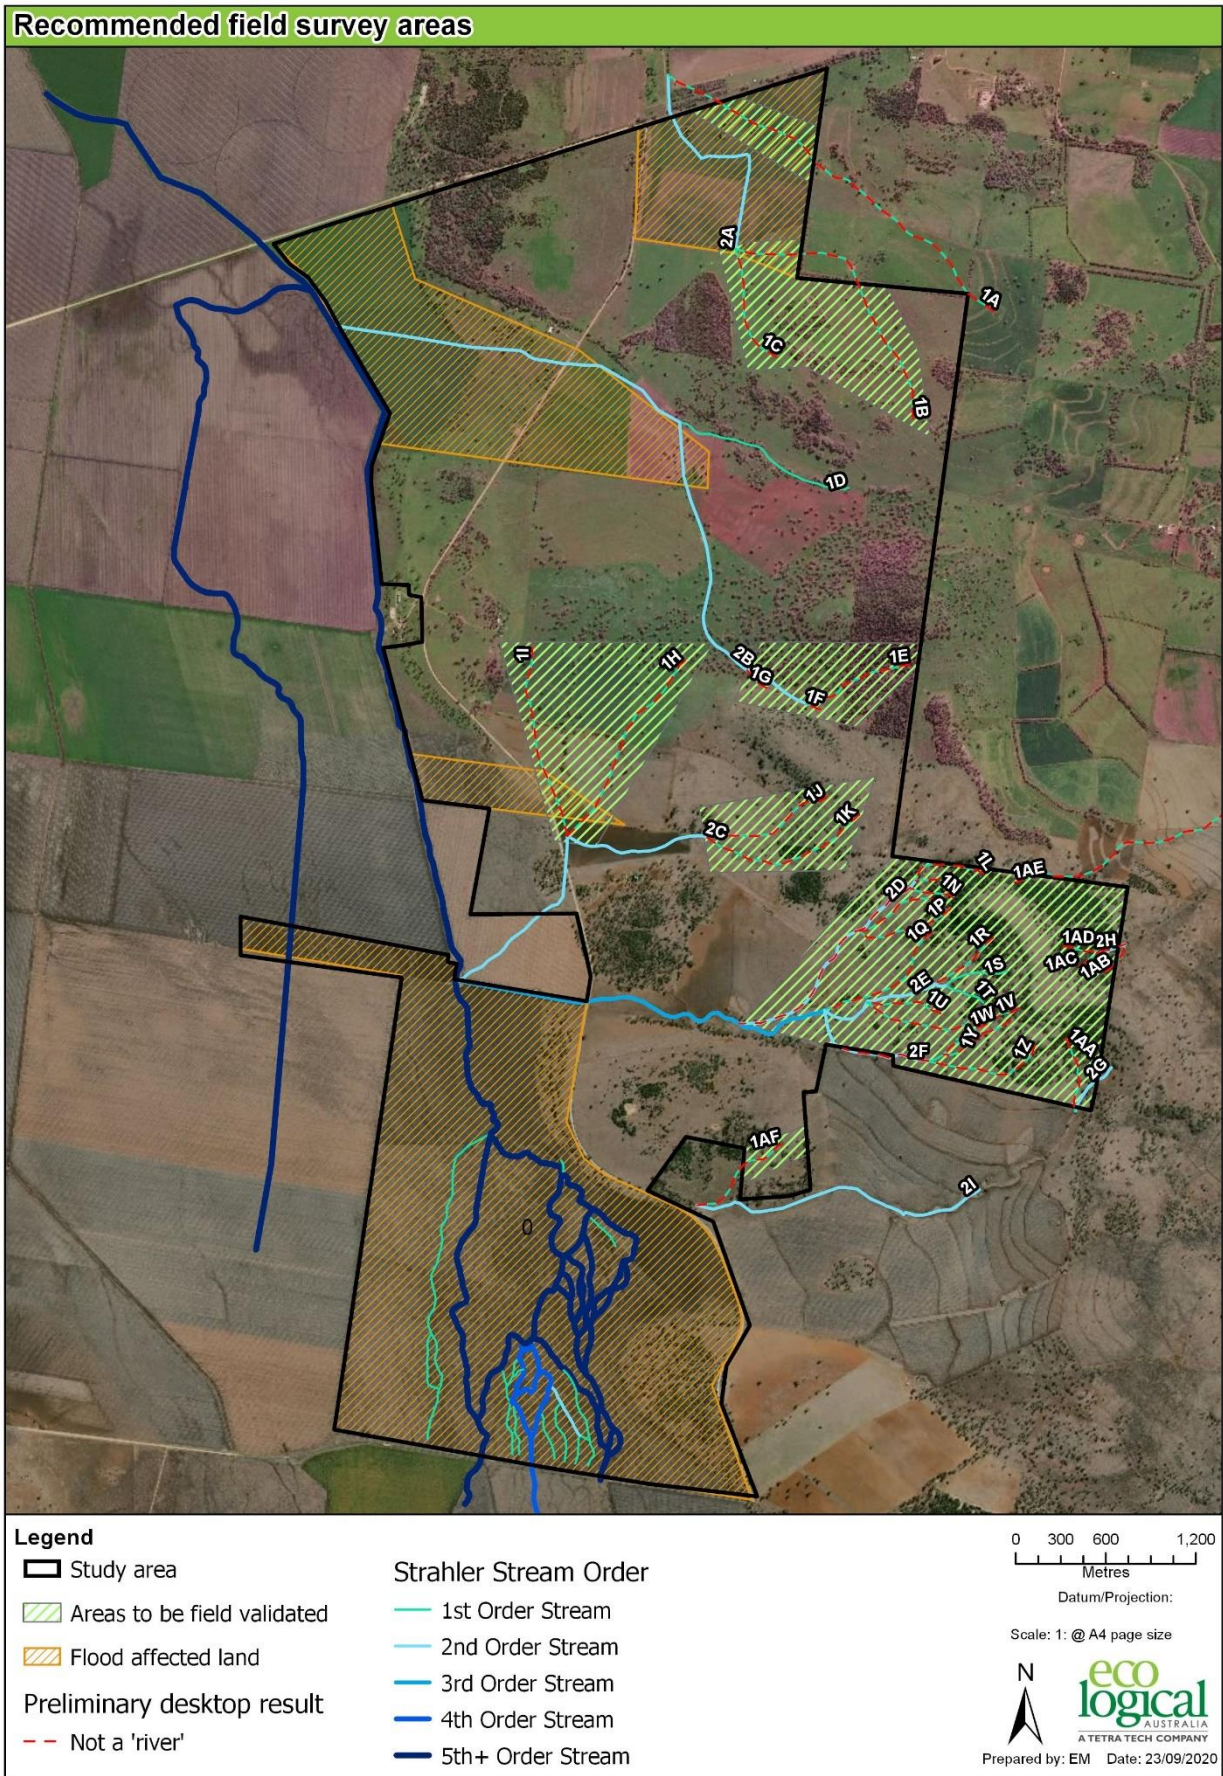
Figure 5: Areas targeted during the field survey

Following the desktop review, watercourses that were deemed unlikely to meet the definition of a river, as shown in Figure 5, were field-validated by two aquatic ecologists on 7 October 2020. Each watercourse was examined for bed, banks and geomorphic processes. Photographs were taken and if the watercourse met the definition of a river, a brief habitat assessment was conducted.

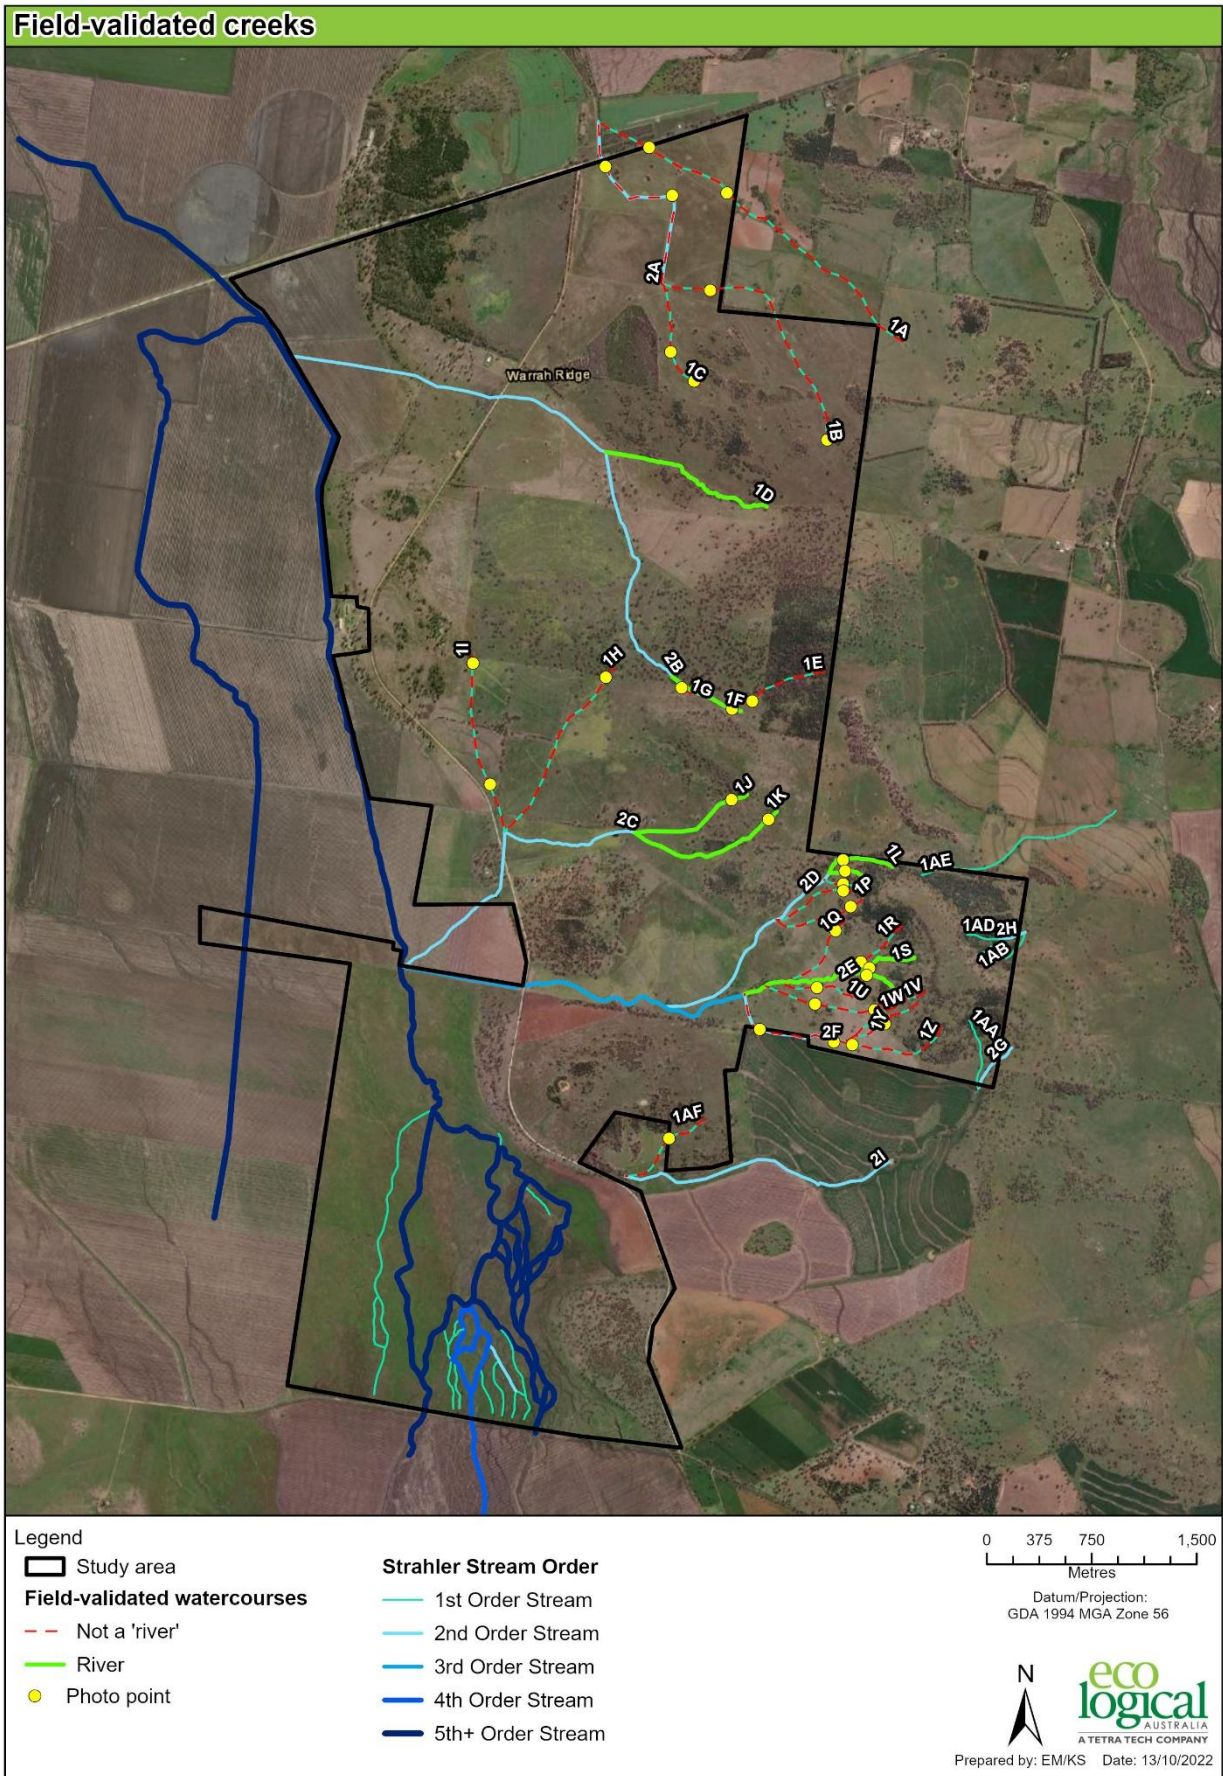
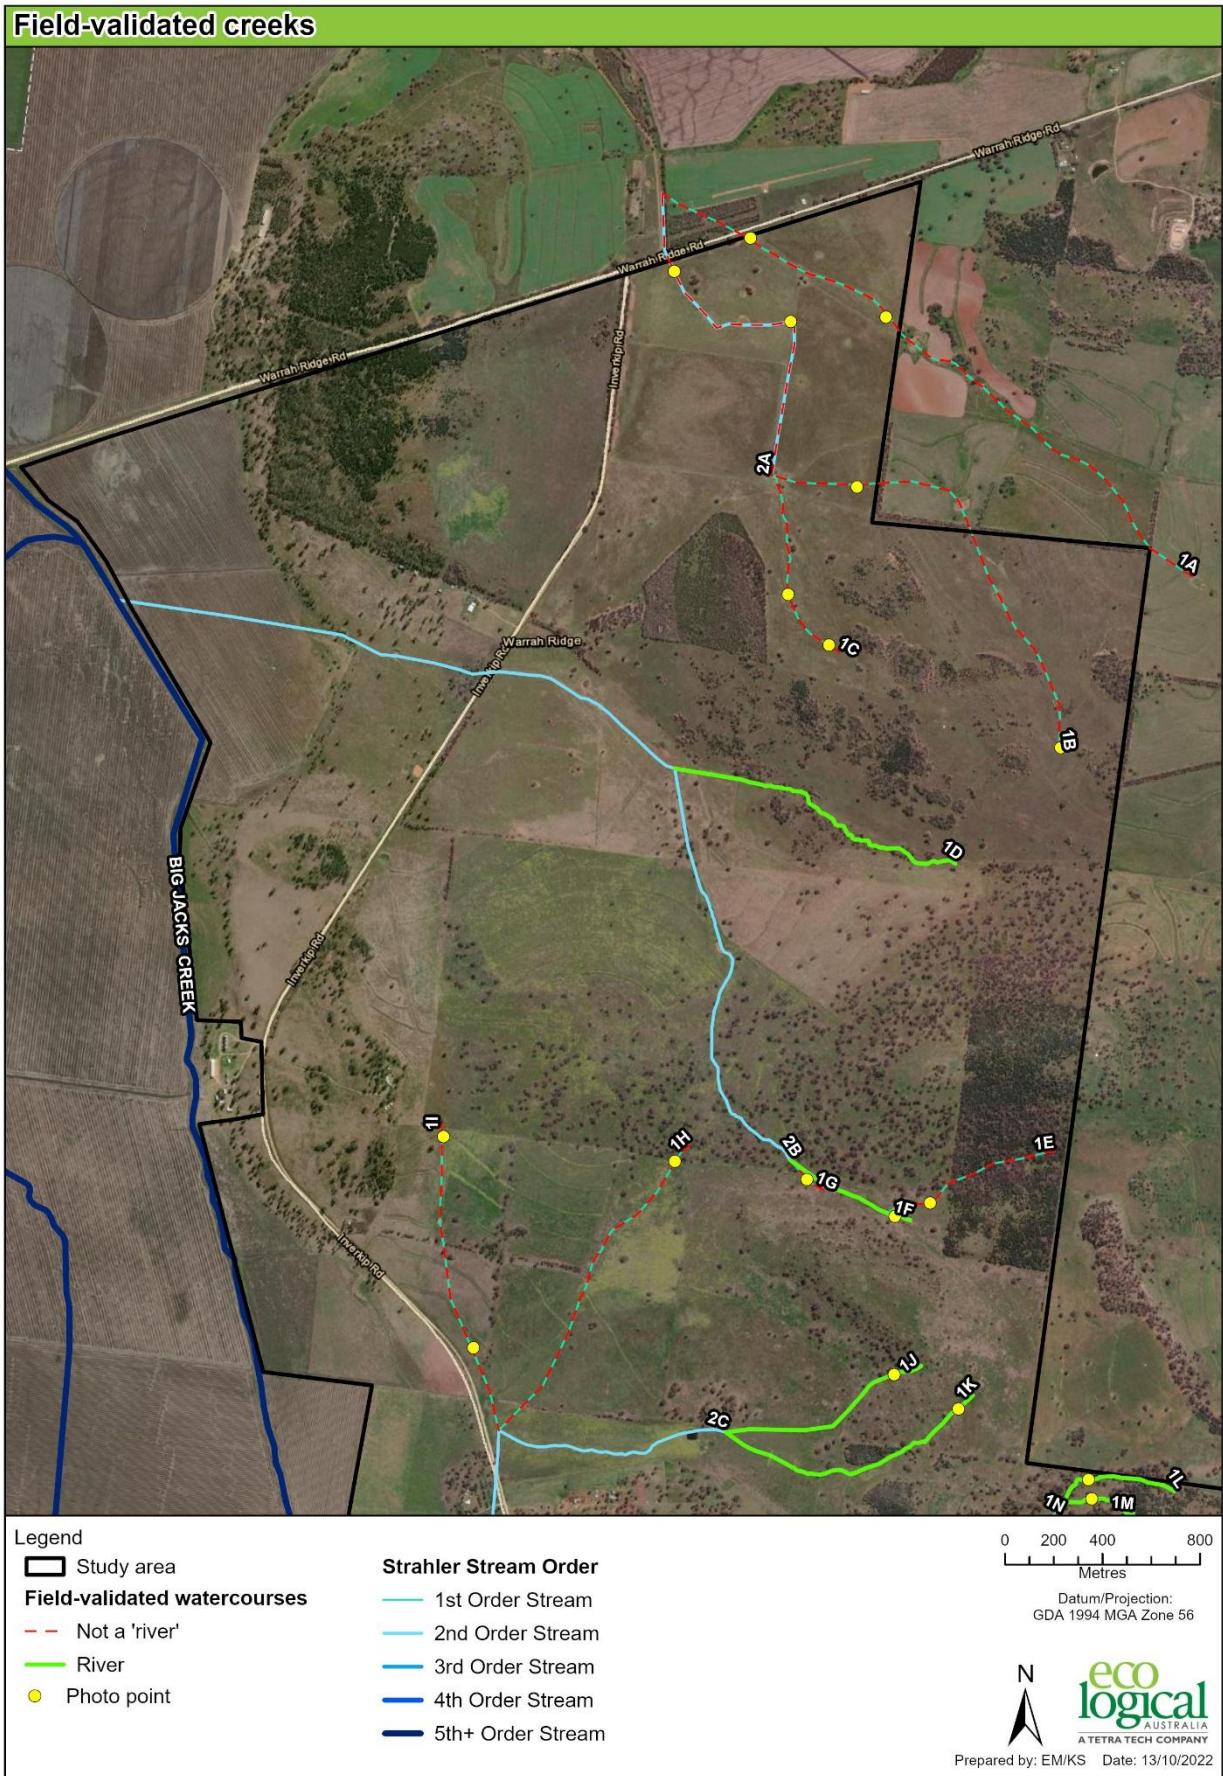
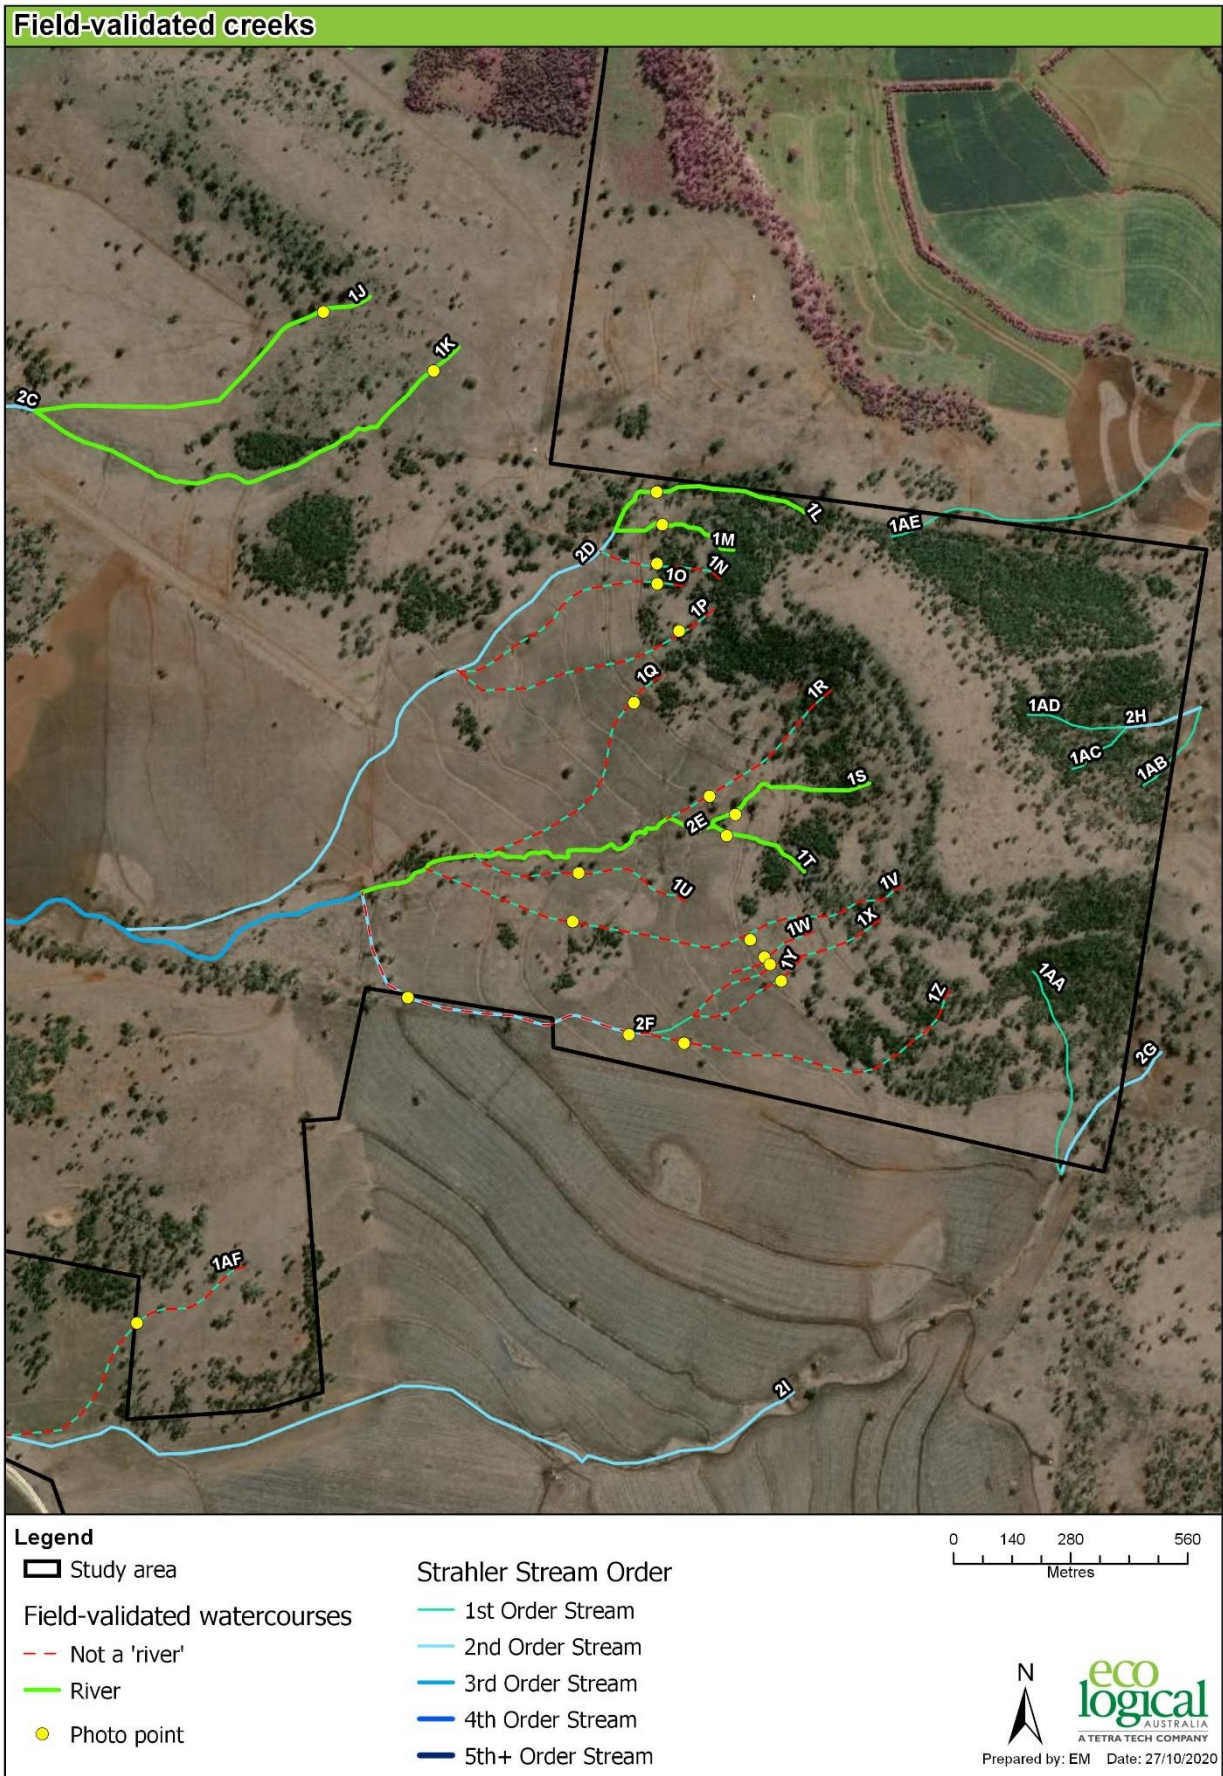
The field-validated 'rivers' are mapped in Figure 6, Figure 7 and Figure 8. The 100 m buffer was applied to watercourses that had a channel, had a channel present in an upstream reach or that was not field-validated and was larger than a second-order watercourse, and are therefore considered likely to meet the definition of a 'river' (Figure 9).

Areas outside these buffers are considered the least constrained to development from an aquatic perspective. Photographs and brief descriptions for each photo point are provided in Appendix A. The site was highly modified, with agricultural practices impacting the surveyed waterways. Extensive contouring had modified the natural flow of waterways by either channelling along the contour and then into a dam or by stopping the flow altogether. All creeks surveyed were ephemeral and would provide temporary habitat for fish and wader birds during times of flow only. However, there was potential frog habitat in the sedges and rushes present in some of the watercourses.

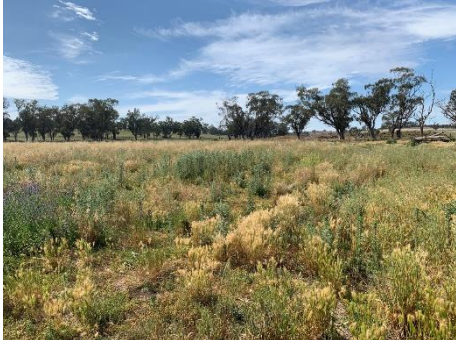
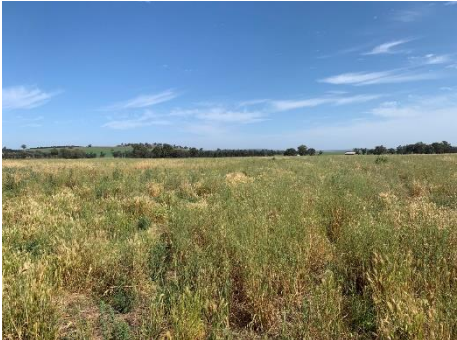
Watercourse	Result	Comment	Photo point*	Facing upstream	Facing downstream
1A	Not a river	Lacked a bed, bank or geomorphic processes. No distinction from surrounding paddock.	1

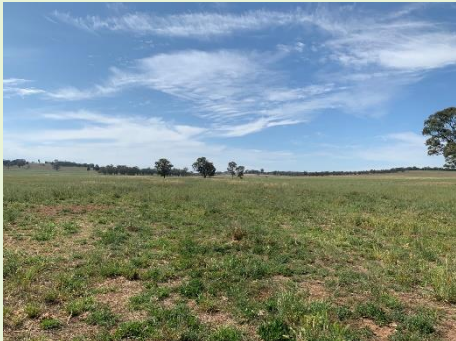
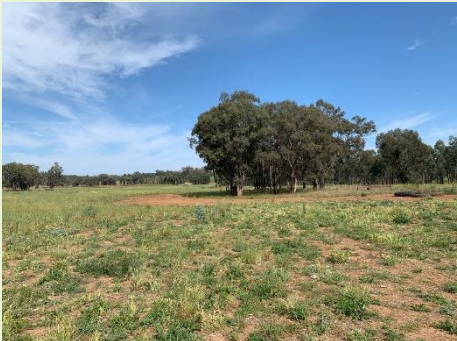
1A	Not a river	Lacked a bed, bank or geomorphic processes. No distinction from surrounding paddock.	2

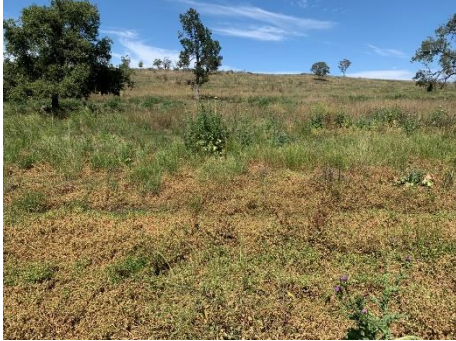
Watercourse	Result	Comment	Photo point*	Facing upstream	Facing downstream
1G	Not a river	Lacked a bed, bank or geomorphic processes. No distinction from surrounding paddock.	1

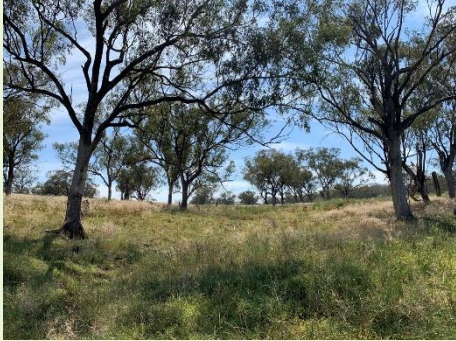
1H	River	Ephemeral watercourse with bed and banks clearly defined. Mature Greybox present along banks. Channel becomes vague downstream of fence, where vegetation was dominated by Thistles and Canola.	1

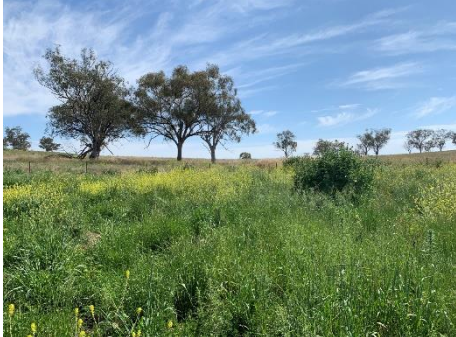
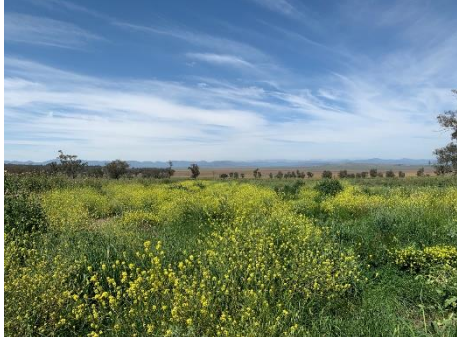
1I	Not a river	Lacked a bed, bank or geomorphic processes. No distinction from surrounding paddock.	1

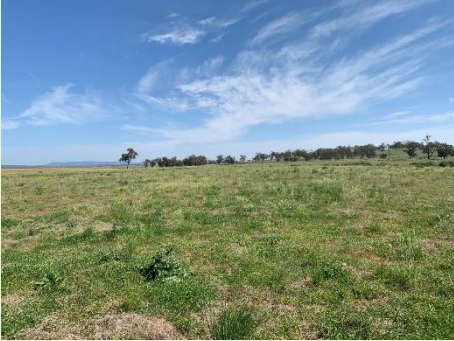
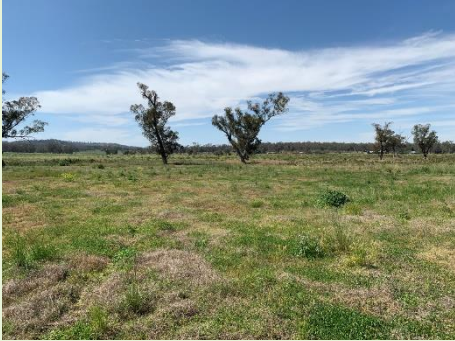
Watercourse	Result	Comment	Photo point*	Facing upstream	Facing downstream
1I	Not a river	Lacked a bed, bank or geomorphic processes. No distinction from surrounding paddock.	2

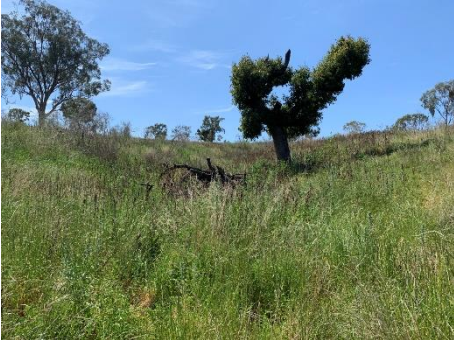
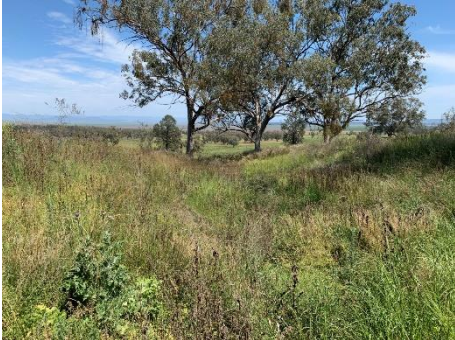
1J	River	Moderate condition – Ephemeral broad v-shaped channel approximately 3 m deep. Scattered mature Eucalyptus form the riparian vegetation.	1

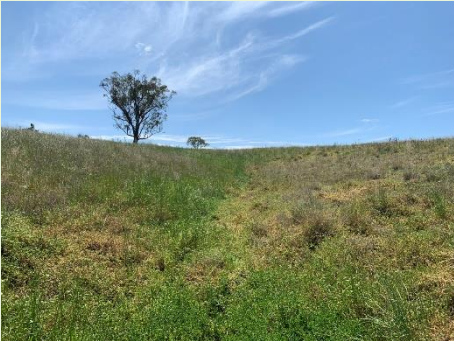
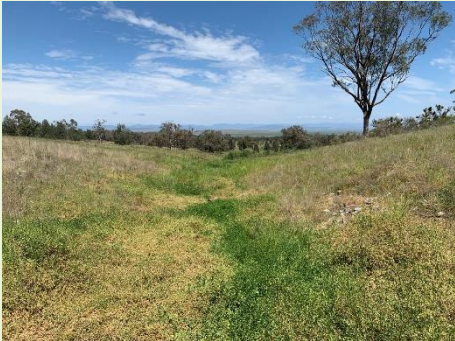
1K	River	Moderate condition – Ephemeral watercourse, 3 m wide and 40 cm deep. Basalt lined the channel.	1

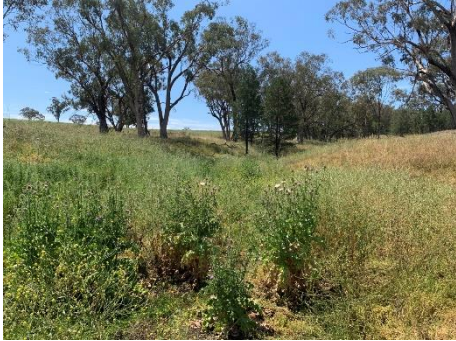
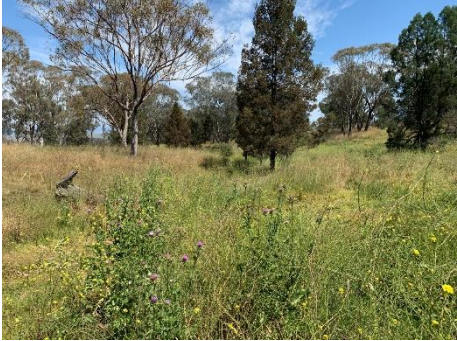
Watercourse	Result	Comment	Photo point*	Facing upstream	Facing downstream
1L	River	Moderate condition – Clearly defined u-shaped channel, 3 m deep with a gravel / cobble base. Native riparian corridor.	1

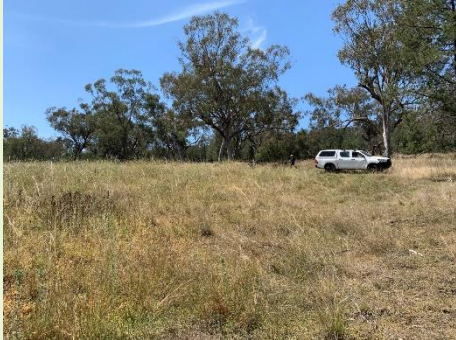
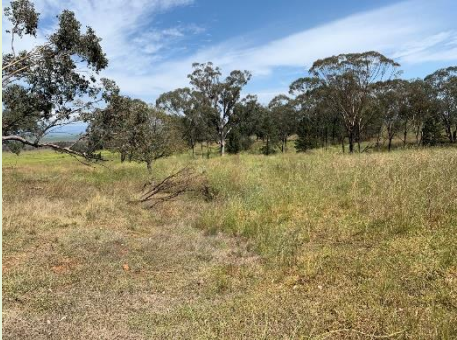
1M	River	Poor condition – Small broad ephemeral watercourse. 50 cm deep and 2 m wide. Upstream the riparian corridor was mature native vegetation, downstream the channel was poorly defined, and difficult to distinguish.	1

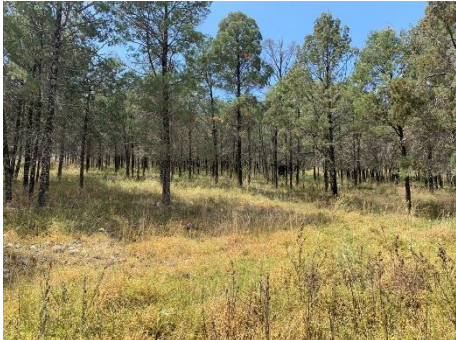
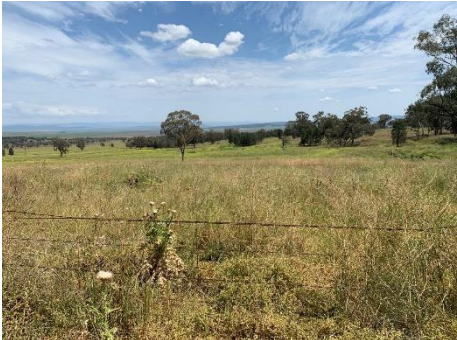
1N	Not a river	Lacked a bed, bank or geomorphic processes. No distinction from surrounding paddock.	1

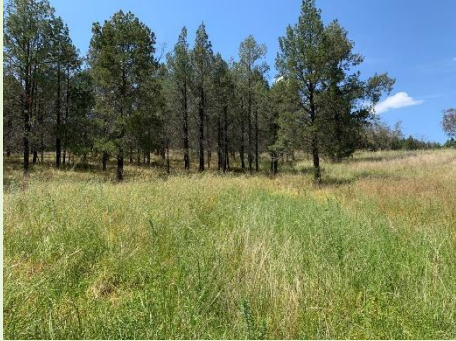
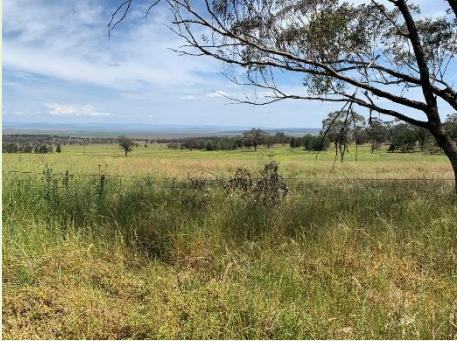
Watercourse	Result	Comment	Photo point*	Facing upstream	Facing downstream
1O	Not a river	Lacked a bed, bank or geomorphic processes. No distinction from surrounding paddock.	1

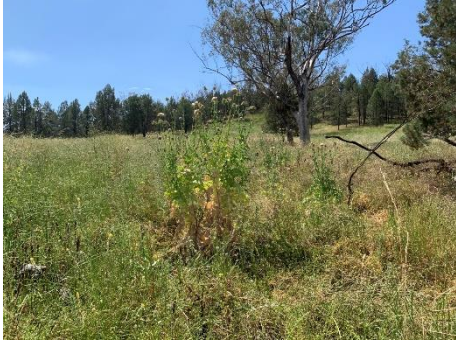
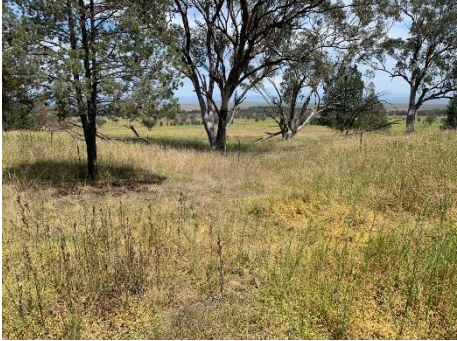
1P	Not a river	Lacked a bed, bank or geomorphic processes. No distinction from surrounding paddock.	1

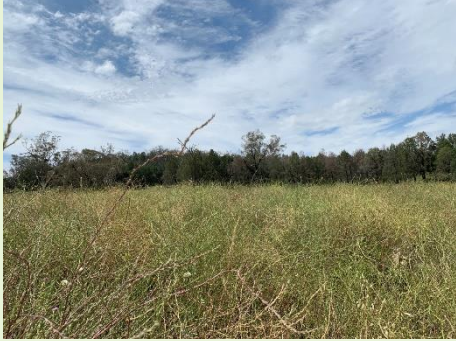
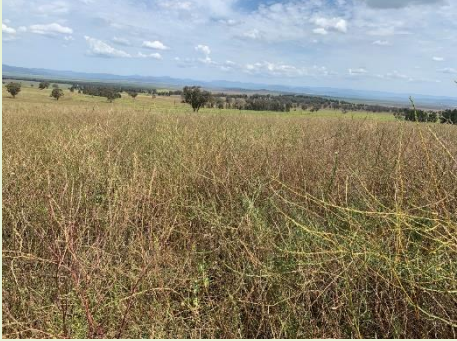
1Q	Not a river	Lacked a bed, bank or geomorphic processes. No distinction from surrounding paddock.	1

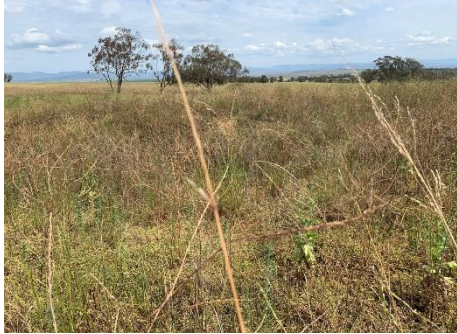
Watercourse	Result	Comment	Photo point*	Facing upstream	Facing downstream
1R	Not a river	Lacked a bed, bank or geomorphic processes. No distinction from surrounding paddock.	1

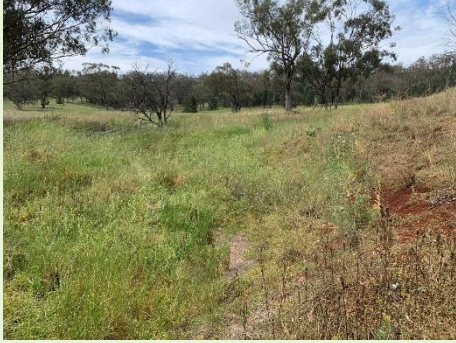
1S	River	Moderate condition – Clearly defined u-shaped channel. Ephemeral only. Upstream the riparian corridor was mature native vegetation. Downstream, scattered paddock trees lined the bank.	1

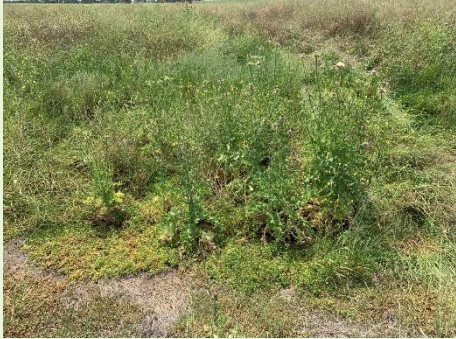
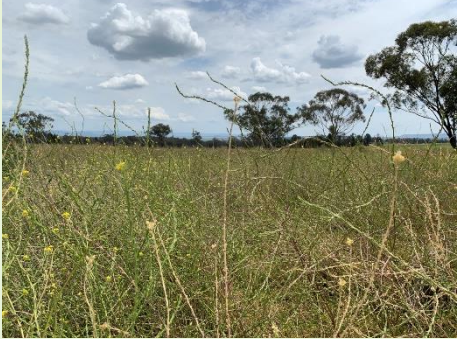
Watercourse	Result	Comment	Photo point*	Facing upstream	Facing downstream
1U	Not a river	Lacked a bed, bank or geomorphic processes. No distinction from surrounding paddock.	1

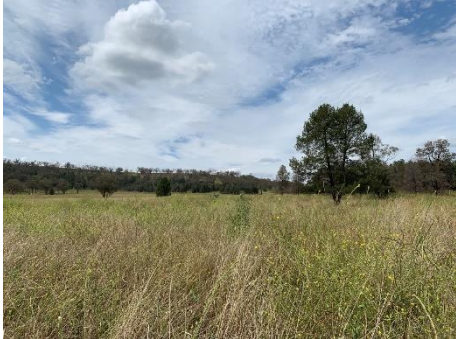
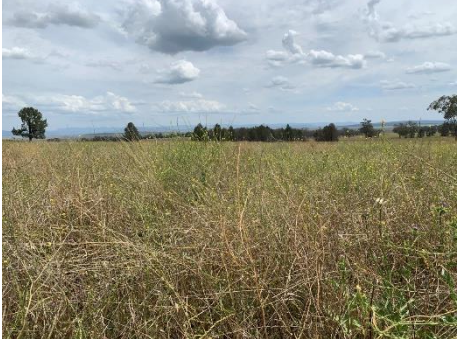
1V	Not a river	Lacked a bed, bank or geomorphic processes. No distinction from surrounding paddock.	1

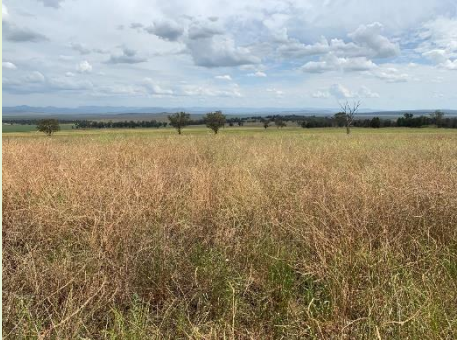
1W	Not a river	Lacked a bed, bank or geomorphic processes. No distinction from surrounding paddock.	1

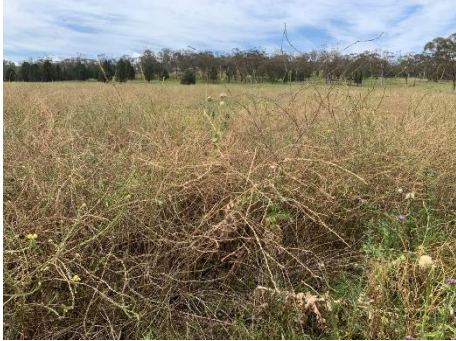
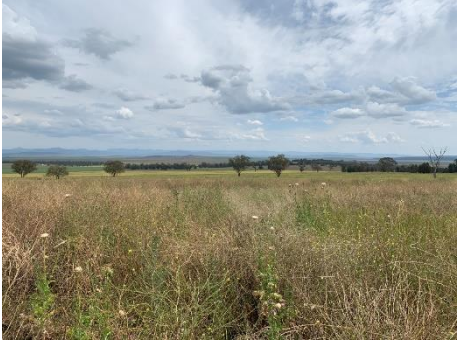
Watercourse	Result	Comment	Photo point*	Facing upstream	Facing downstream
1Y	Not a river	Lacked a bed, bank or geomorphic processes. No distinction from surrounding paddock.	1

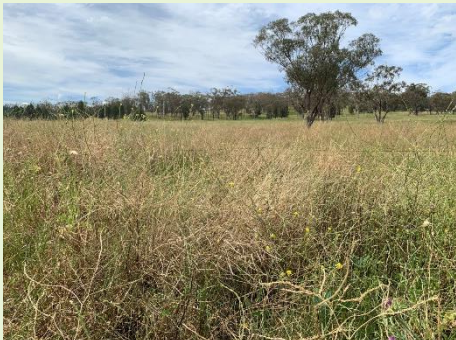
1X	Not a river	Lacked a bed, bank or geomorphic processes. No distinction from surrounding paddock.	1

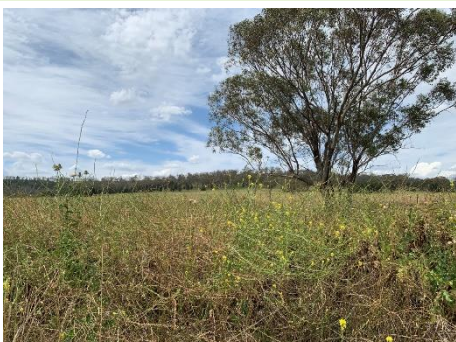
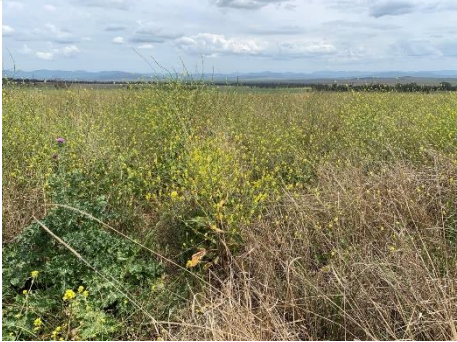
1Z	Not a river	Lacked a bed, bank or geomorphic processes. No distinction from surrounding paddock.	1

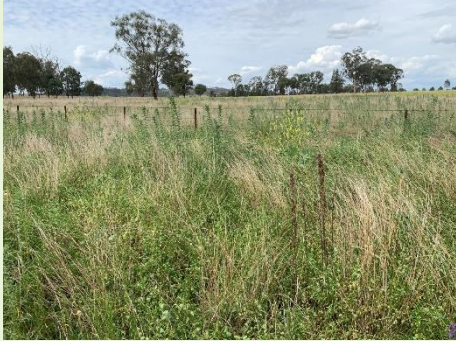
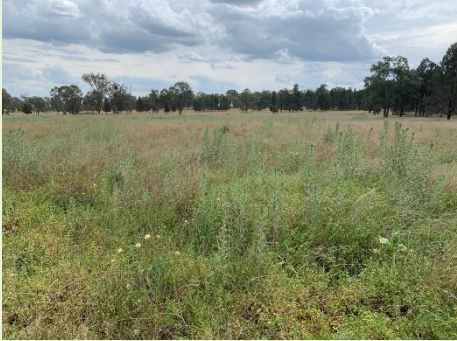
Watercourse	Result	Comment	Photo point*	Facing upstream	Facing downstream
1AF	Not a river	Lacked a bed, bank or geomorphic processes. No distinction from surrounding paddock.	1

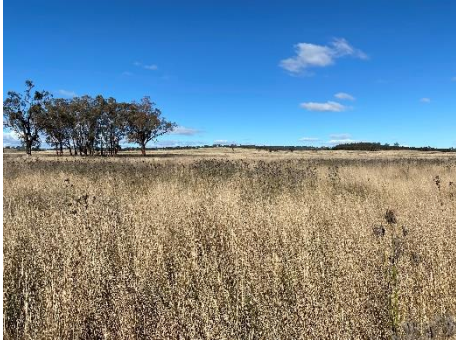
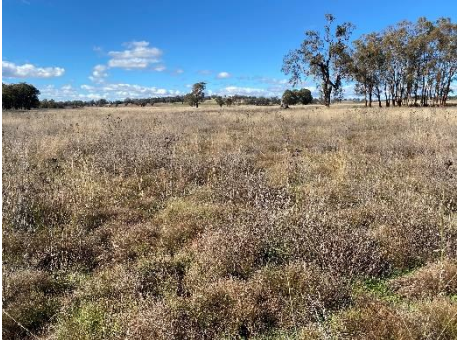
2A	Not a river	<p>Lacked a bed and banks. Sedimentary materials suggest fluvial movement during high rainfall (large proportion of unevenly sized pebbles), though these were located just off a slight rise where mature trees were present, indicating scree material. Whilst no defined channel was present, areas of open depression do fill with water during rain events, indicated by circular patches of aquatic vegetation such as <i>Juncus sp.</i></p> <p>The east-west aligned portion of stream 2A does have banks, however these are artificial to transfer surface water into the nearby dam and non-continuous outside of the paddock. There is</p>
