Willow Tree Waste Management Facility

Landfill Expansion Masterplan

Liverpool Plains Shire Council

13 September 2021

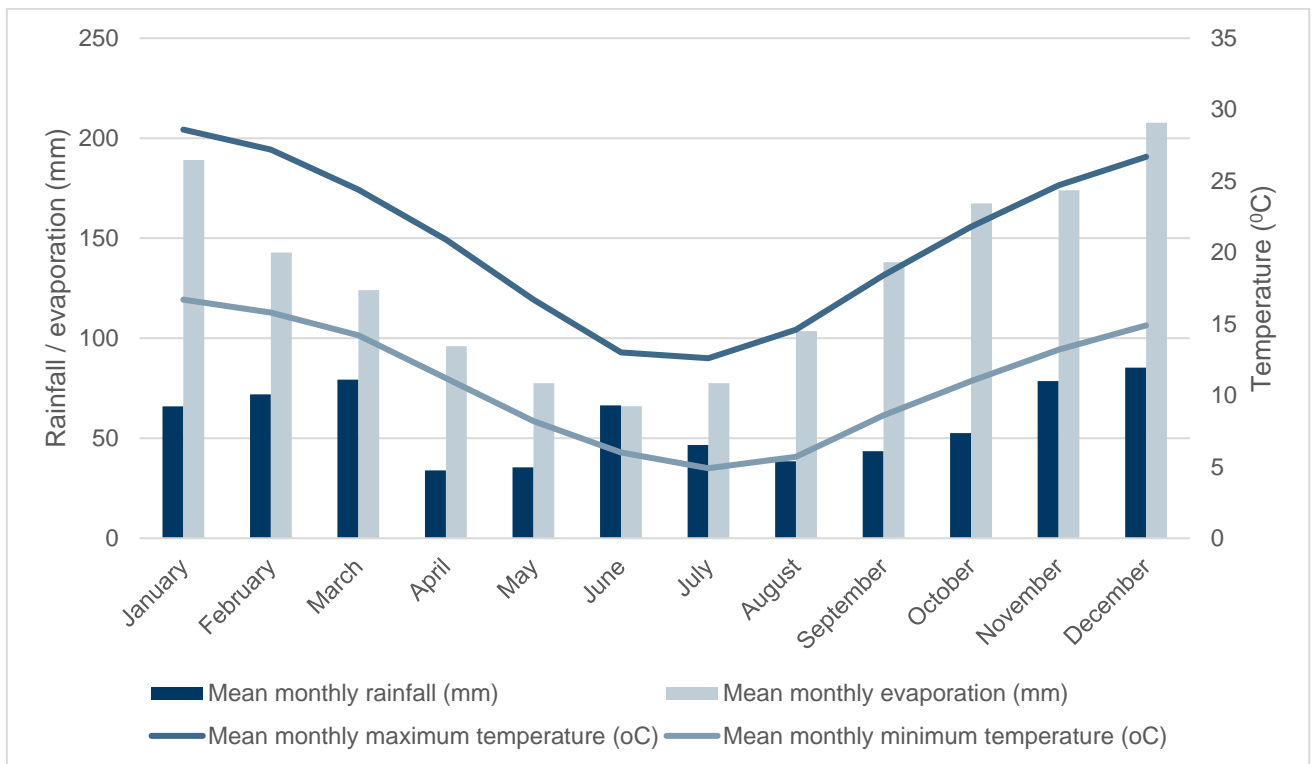
Figure 2.3 Climate statistics

¹ Calculated by multiplying daily rainfall by the number of days in that month, 28 days used for February.

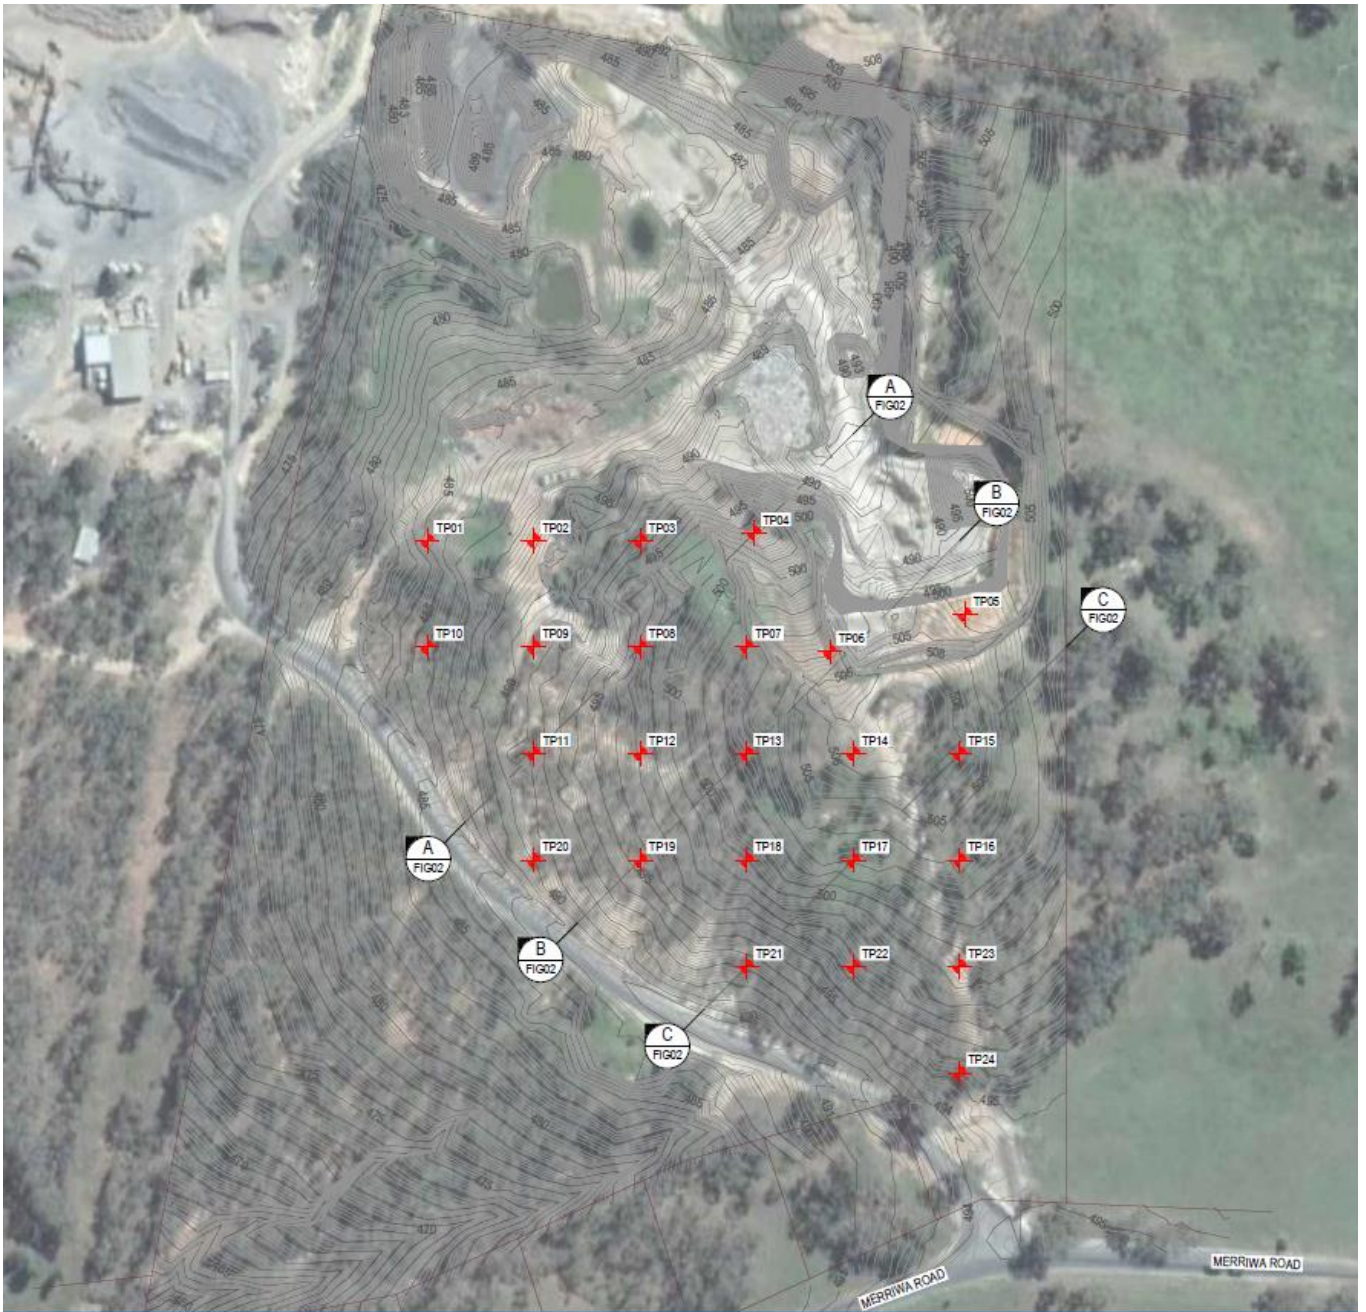
Figure 3.1 Test pit locations (source: GHD (2021a))

GHD completed an initial geotechnical investigation in the southern undisturbed areas to obtain a better understanding of the site geology and geotechnical conditions. The report is contained in Appendix C and findings relevant to the masterplan are summarised below. Test pit locations for this investigation are shown in Figure 3.1.

In the remainder of conditions, practical refusal was due to very slow progress of the auger through less weathered and stronger conglomerate and sandstone. Where previous stripping of surficial weathered material had occurred such as at TP05, TP06 and TP16 refusal was reached at less than 0.3 m depth. In other locations, refusal was reached when rock strength increased below a shallow weathered profile.

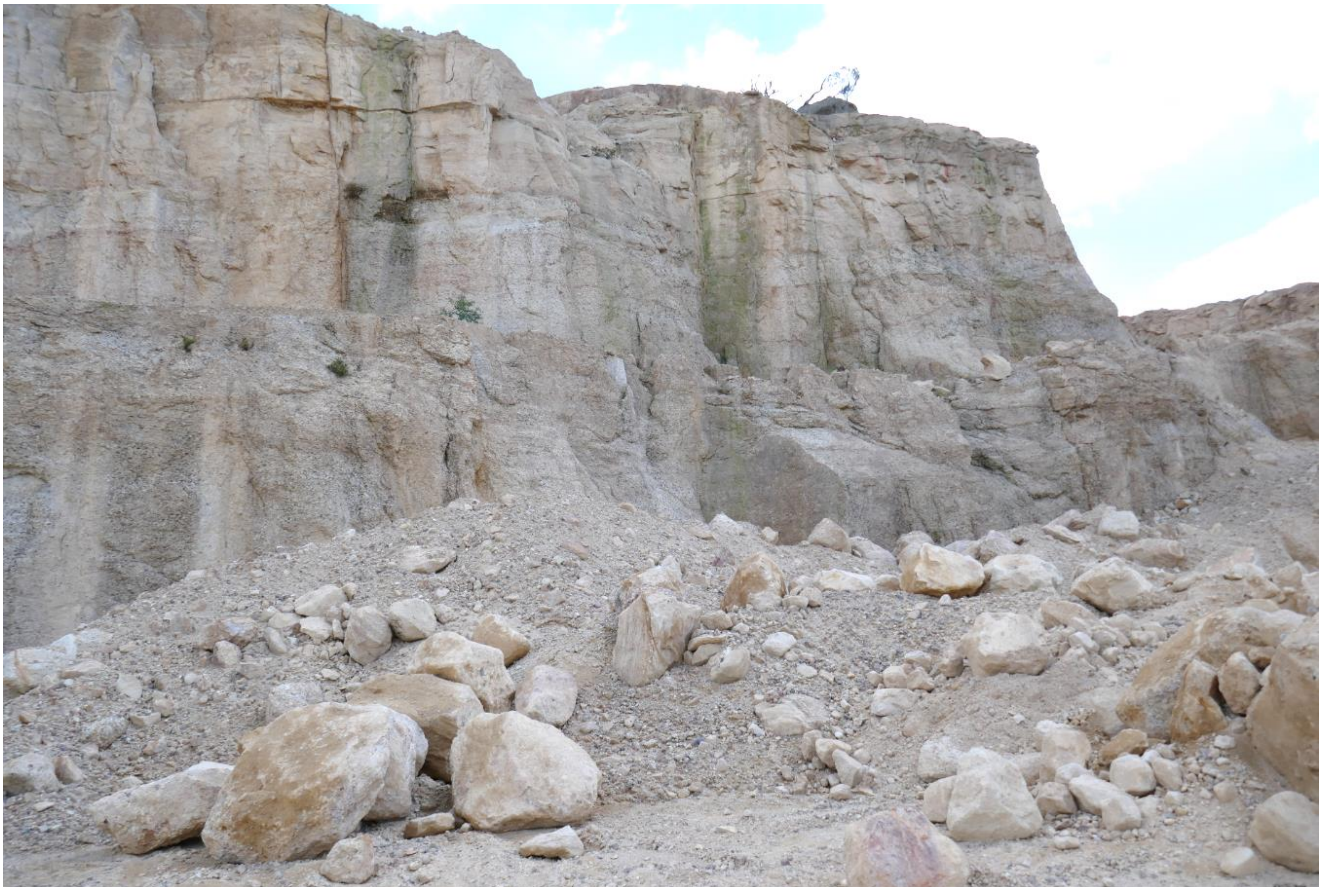
Figure 3.2 Willow Tree Gravel Quarry highwall

Excavation for a landfill cell is expected to be well beyond the limit of the geotechnical investigation. However, a good indication of conditions below this is available from the former quarry and Willow Tree Gravel Quarry where blasting is used. The blasting plans and experience of Willow Tree Gravel in excavating these materials would provide a valuable guide to excavation of rock to create a landfill cell.

To produce a similar material to that created by auger drilling, crushing of oversized material from ripping or blasting would be needed. For very low and low strength materials, use of a grid roller on thinly spread material is likely to be effective in reducing oversize proportions. However, the effectiveness of this technique should be confirmed with a field trial, particularly for breakup of medium strength rock which is expected to comprise a significant proportion of the excavated material.

Re-use functions of the excavated soil and rock for use in landfill operations will depend on how the material is excavated and blended. Based on the observed auger excavated material and products of Willow Tree Gravel from the same rock units the following material uses are expected to be achievable:

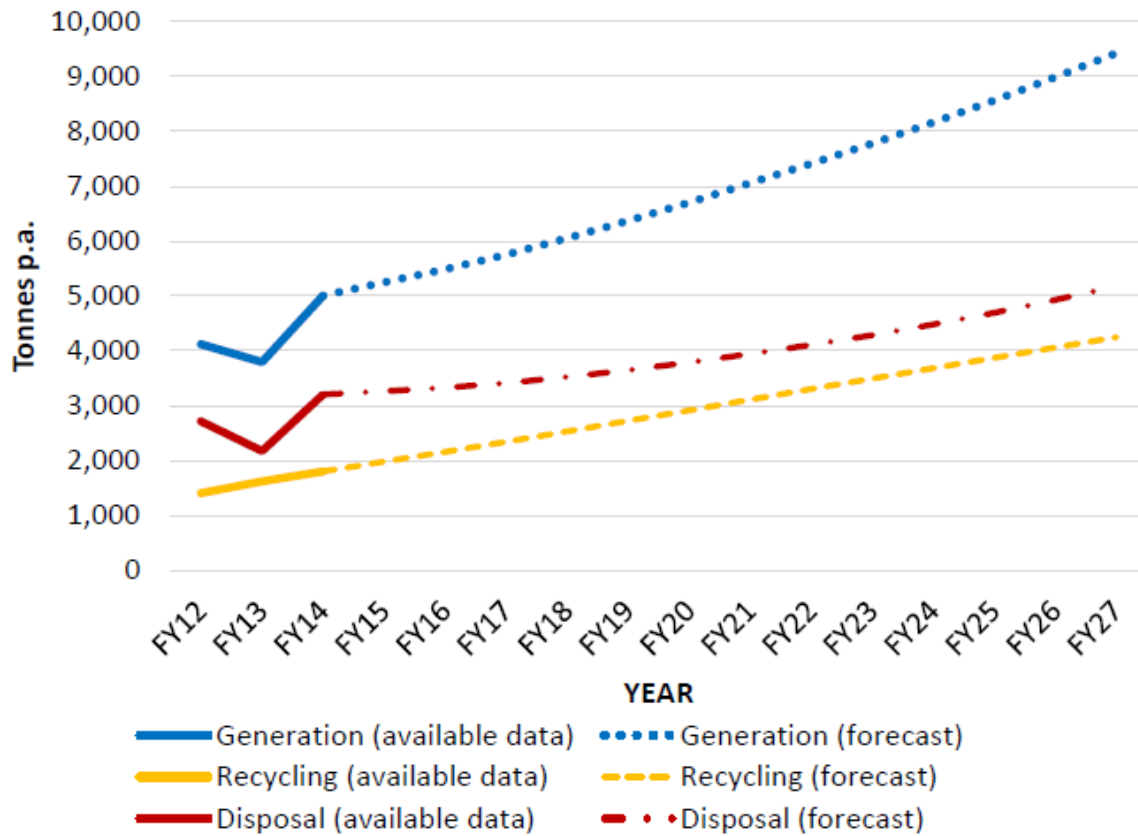
Figure 3.3 Council waste generation, recycling and disposal forecast (FY12-FY27) (source: MRA (2018))

MRA (2018) noted limitations to this estimate, specifically the data for FY12 to FY14 (which comprises the basis of the projections):

It was also noted that the impact of the NSW Government's Container Deposit Scheme (CDS) for drink containers was not included in this projection as the impacts are difficult to predict and are likely to lie within the margin of error for this analysis.

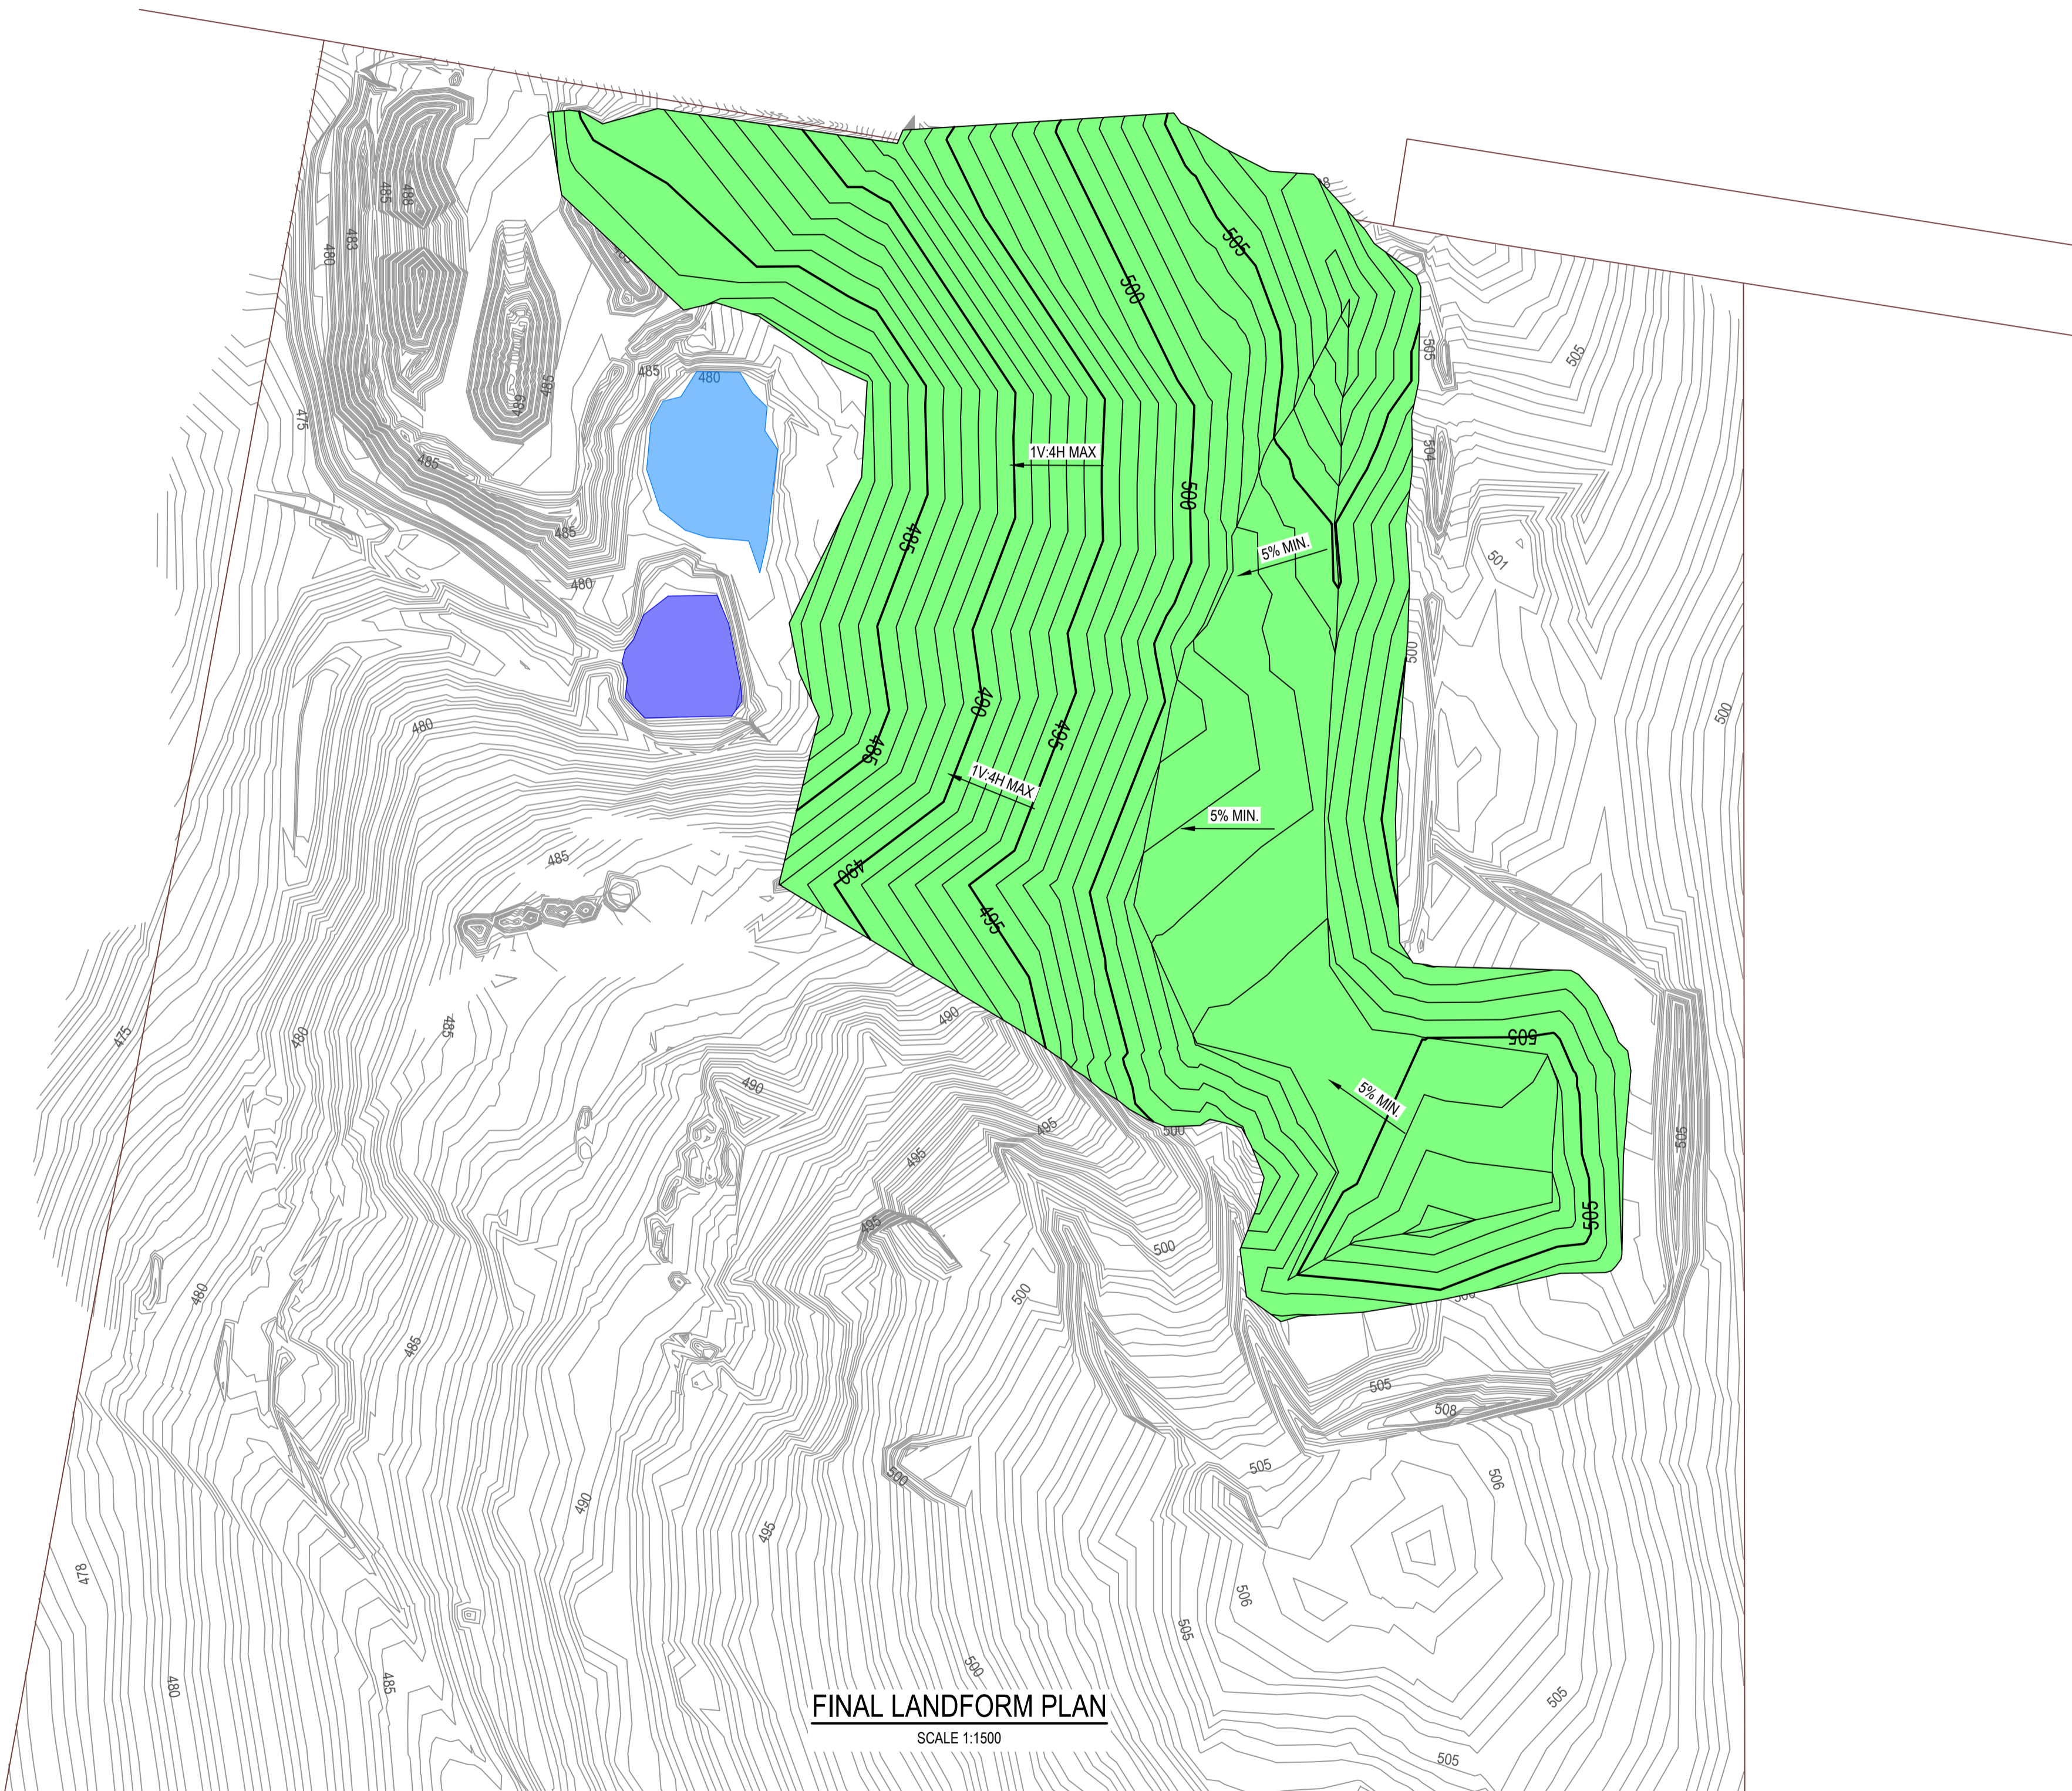
FINAL LANDFORM PLAN
SCALE 1:1500

- 500 EXISTING CONTOURS m A.H.D
- 500 FINAL LANDFORM DESIGN CONTOURS
- CADASTRE
- SURFACE WATER POND
- LEACHATE POND

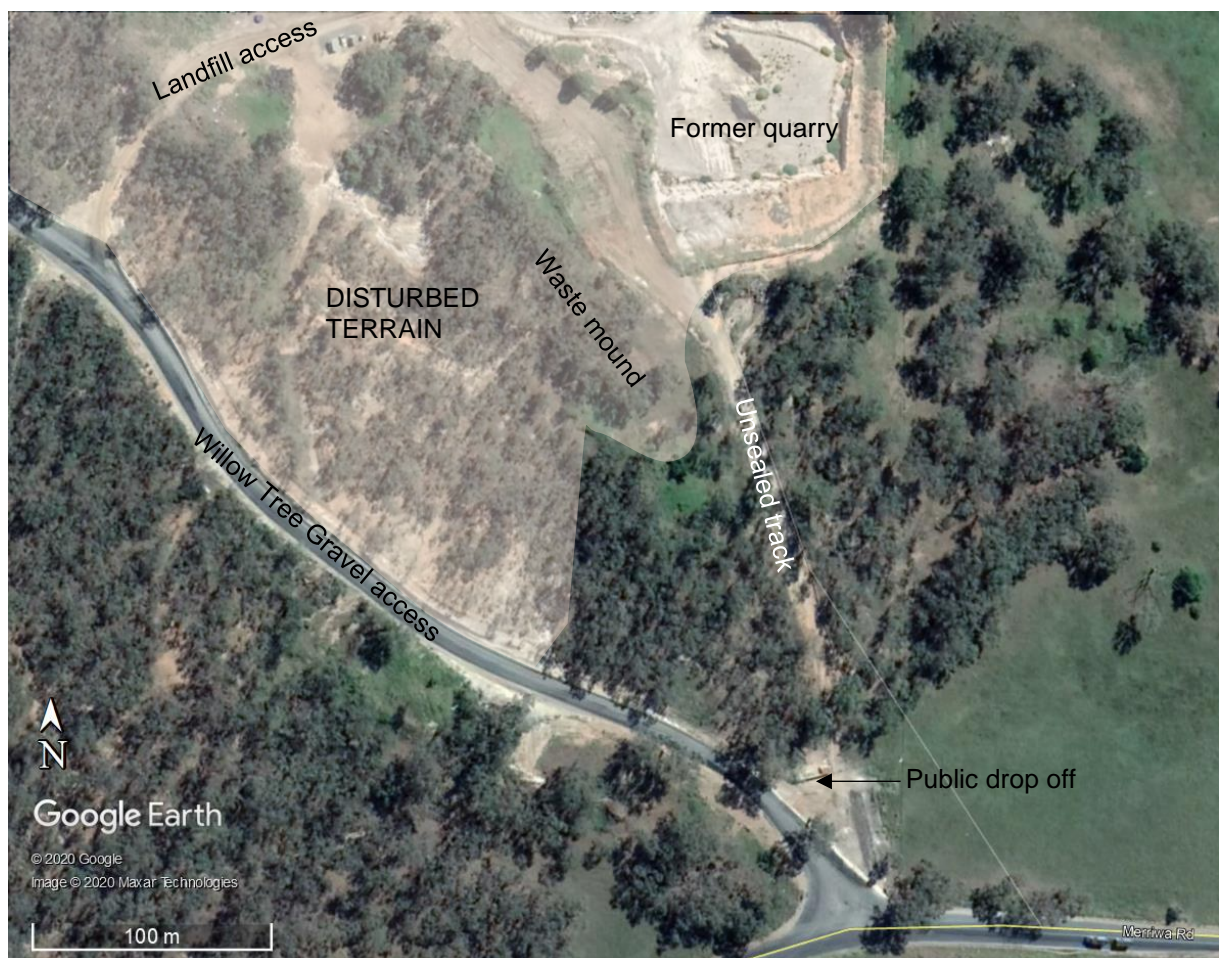
Image 3 Areas of surface disturbance

These areas and features are shown approximately in the below image.

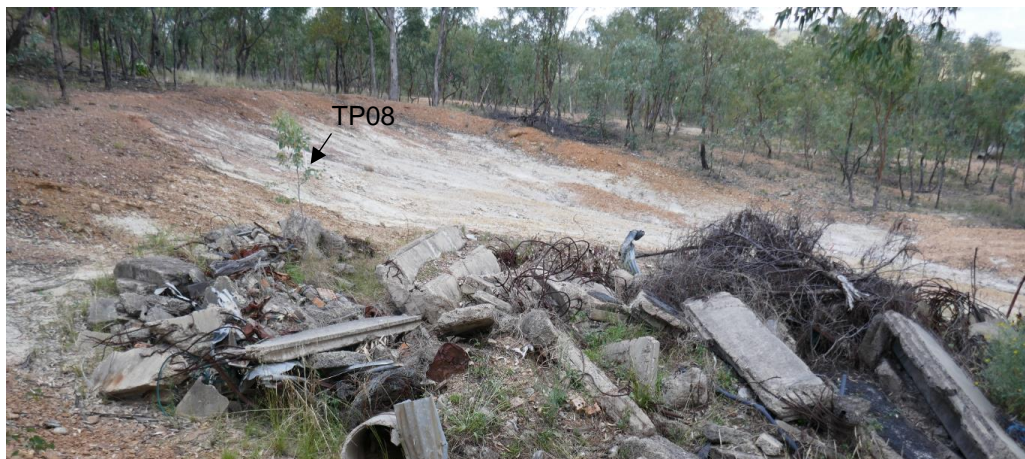
Image 5 Shallow excavation in sandstone at TP08

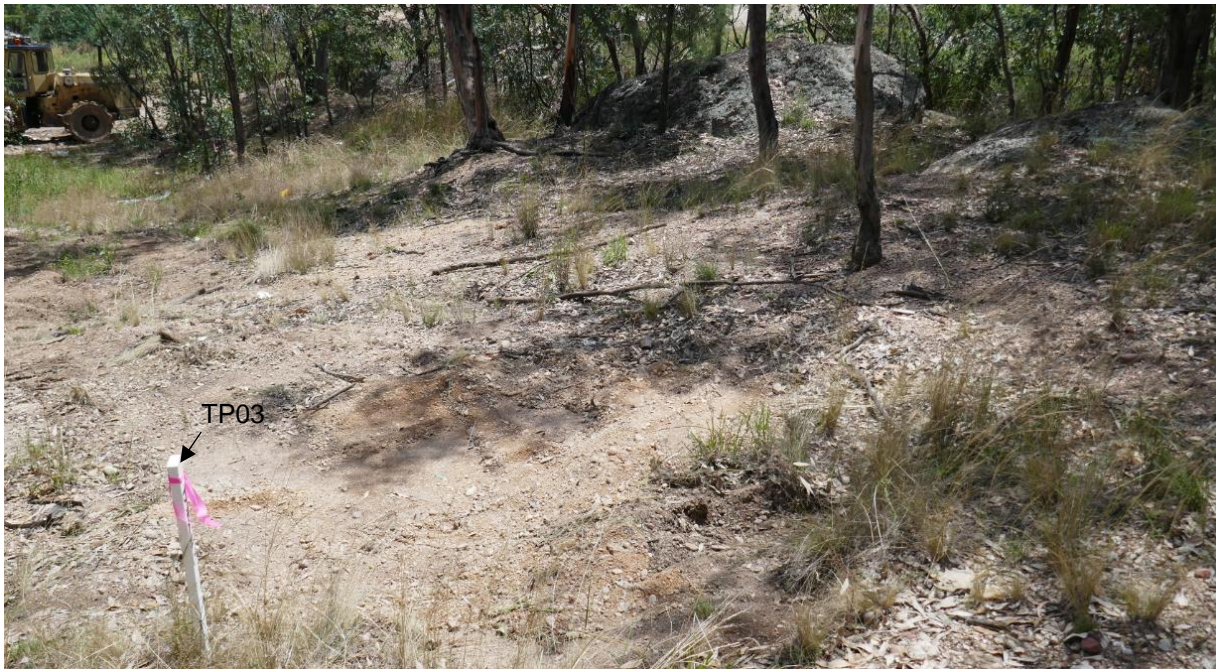
Image 6 Conglomerate ridge – looking north from TP03

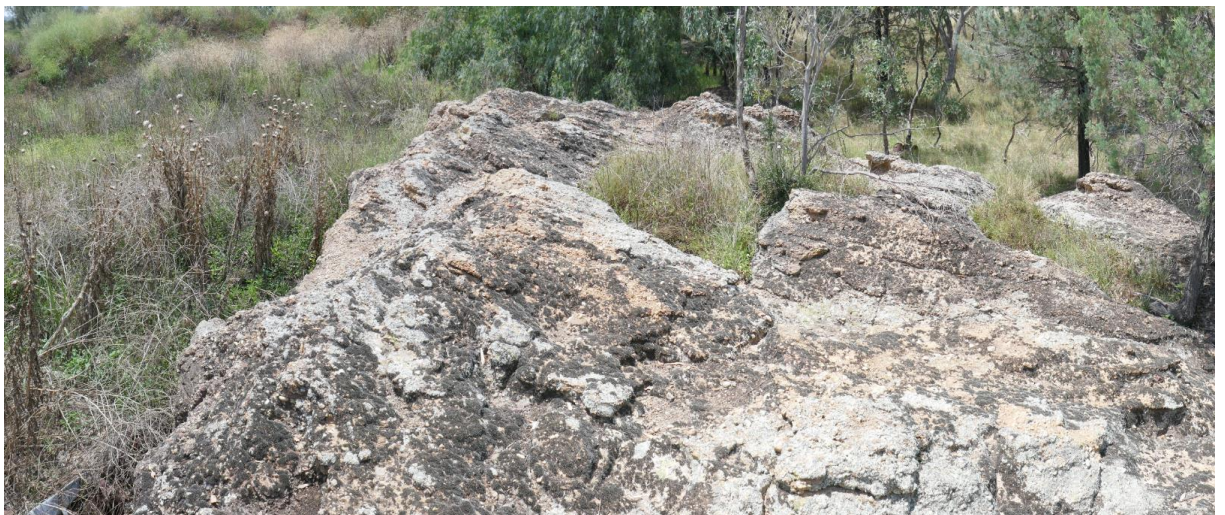
Image 7 Conglomerate ridge – looking south on main block

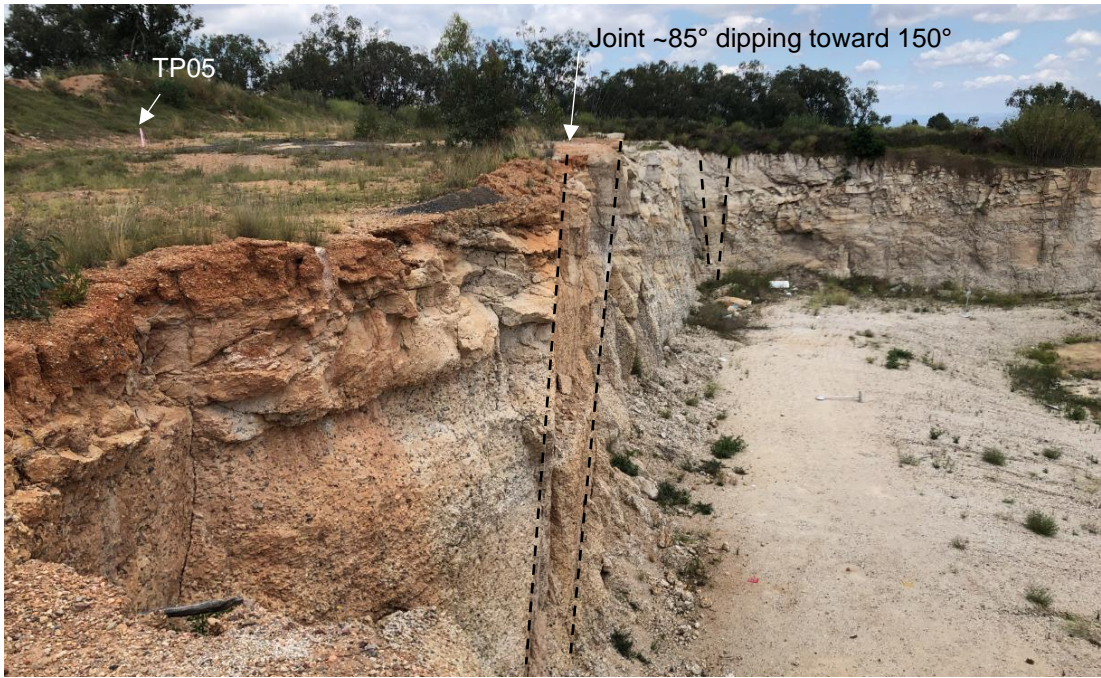
Image 9 Former quarry jointing

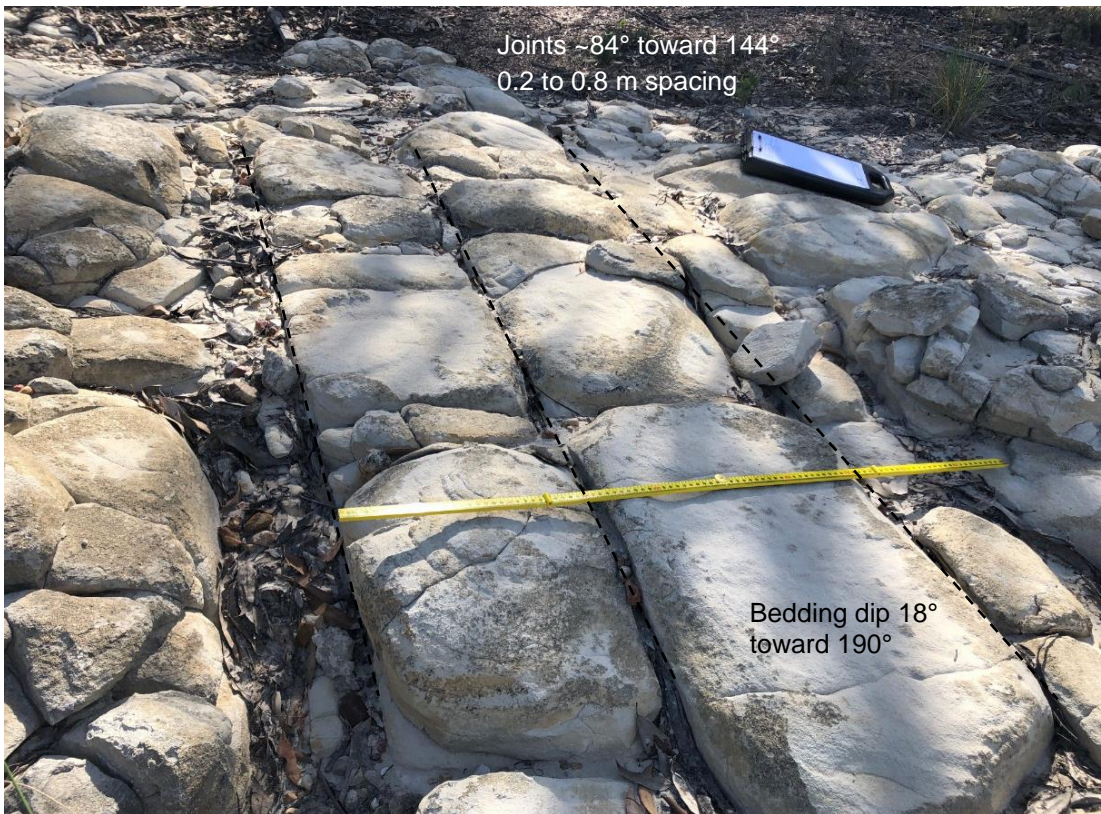
Image 10 Bedding and joints in sandstone along roadside

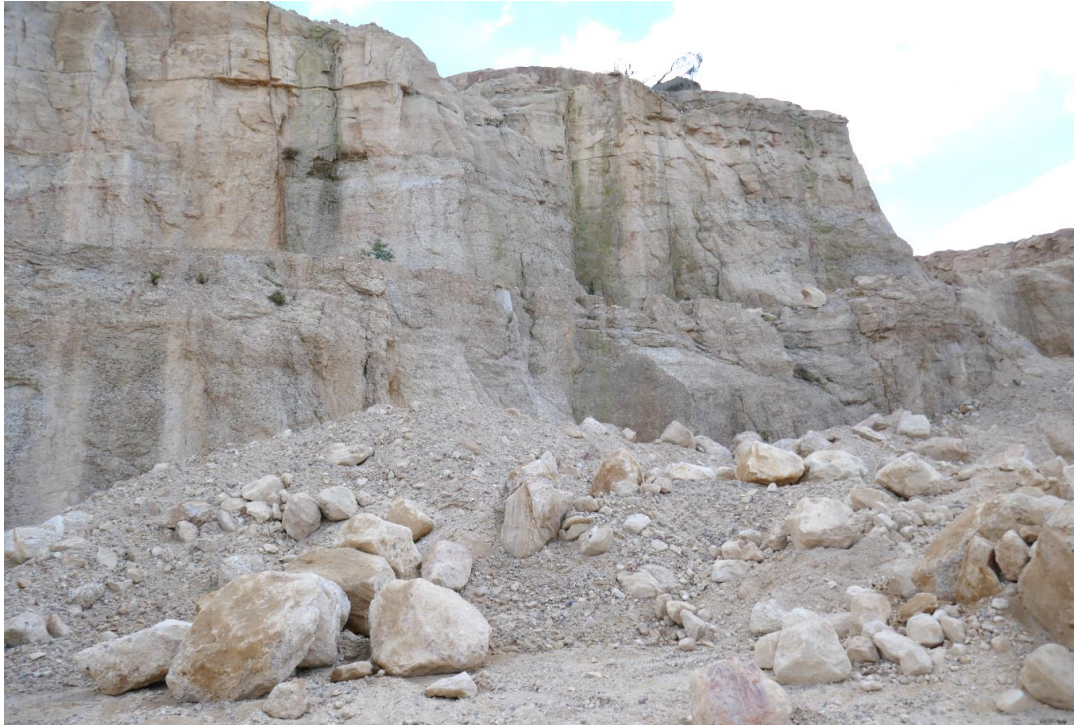
Image 11 Willow Tree Gravel quarry highwall

To produce a similar material to that created by auger drilling, crushing of oversized material from ripping or blasting would be needed. For very low and low strength materials, use of a grid roller on thinly spread material is likely to be effective in reducing oversize proportions. However, the effectiveness of this technique should be confirmed with a field trial, particularly for breakup of medium strength rock which is expected to comprise a significant proportion of the excavated material.
